## Rehabilitation of an old Concrete Lohse Arch Bridge: Replacement of all hanger

The Kimitsu Shinbashi Bridge is a Lohse arch bridge with reinforced concrete arch ribs and prestressed concrete deck slab. On October 23, 2008, it was discovered that one of the 40 hanger connecting the arch ribs and deck slab had broken. The bridge was closed to traffic and breaking mechanism followed by a detailed investigation. Repairs were effected step by step, ensuring the safety of the bridge throughout the process. This report describes the circumstances and procedures leading up to the replacement of hanger, and reports on the hanger replacement work utilizing newly developed tension releasing equipment.

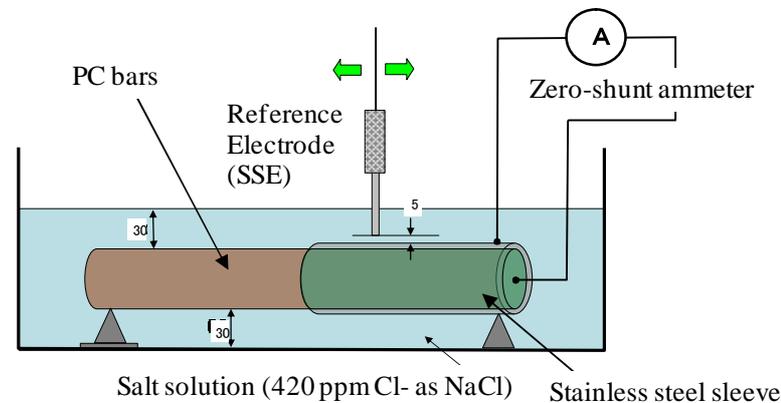
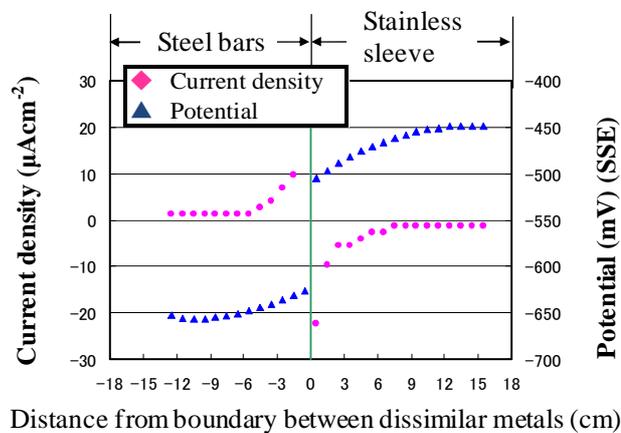
**Figure 1. Steel corrosion test**

This test showed that although there was no continuity at points on the steel bar where the coating remained, there was electrical continuity when the coating was removed. To discover the cause of corrosion, the anti-corrosion paint was removed from a steel bar, and a dissimilar metals corrosion test (galvanic corrosion test) performed between the steel bar and the stainless steel sleeve. The test showed that galvanic current between the steel bars and stainless steel sleeve significantly promoted corrosion of the steel bars near a boundary. Figure 1 outlines the galvanic corrosion test and the results obtained. A current density of  $20 \mu\text{Acm}^{-2}$  was produced at the boundary between the steel bar and sleeve.

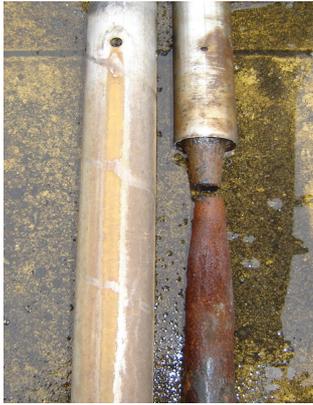
**Photo 2. Broken steel bar**

An emergency investigation performed immediately after break of the hanger consisted of recovering the broken steel bar and visually inspecting the extent of corrosion and the breaking section. The steel bar had broken close to a joint in the sheath pipe. As can be seen in Photo 2, the anti-corrosive paint applied at the time of construction was peeling, and substantial corrosion had occurred, reducing tendon diameter from 32 mm to only 19 mm. Investigating other hanger revealed additional cases where the steel bars had reduced thickness due to corrosion, so the bridge was closed to traffic.

Detailed investigations were conducted to discover the cause of break of the steel bar. Table 2 shows the Items covered by the investigations, together with the results. Material tests on the steel bar did not find any abnormalities in terms of chemical constituents, metallographic structure, hardness, or tensile strength, so it was judged that there were no deficiencies in terms of materials. Furthermore, examination of the breaking surface suggests that rather than ductile fracture, this breaking was a brittle fracture starting at the section where the surface was corroded.

Tests	Results
Material tests	Appearance	Section reduced to 35% at point of breaking
	Chemical constituent analysis	JIS standards compliant
	Metal structure observation	OK
	Hardness measurement	OK
	Tensile test	JIS standards compliant
Dissimilar metals corrosion testing	Galvanic corrosion test	Corrosion likely (Corrosion current density: $20 \mu\text{A}/\text{cm}^2$ )

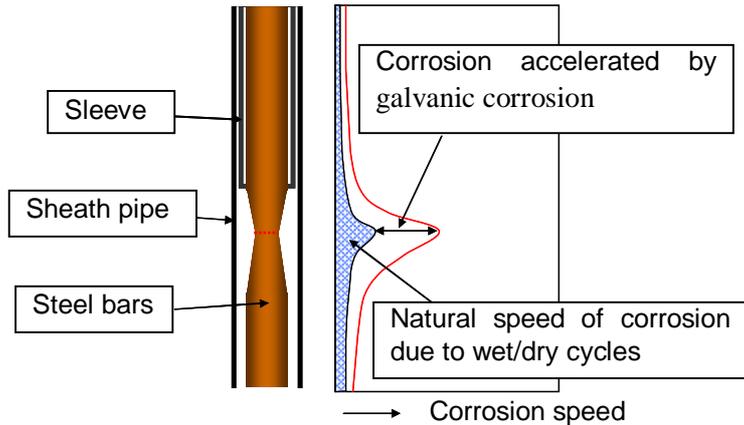
**Figure 2. Corrosion mechanism**

From the results of these investigations, it is surmised that the joint between sheath pipes protecting the steel bar separated due to degradation and vibration, that, in addition, dissimilar metals corrosion occurred due to partial electrical contact between the stainless steel sheath pipe/sleeve and the steel bar, and that the steel bar subject to conspicuous reduction of cross-section lost resistance capacity and had broken. This corrosion mechanism is illustrated in Figure 2.

Since the cause of break of the hanger was corrosion, it was decided to replace the steel bars with PC cables. The cables have a dual protective coating, provide greater corrosion performance, and moreover meet current standards. To further enhance corrosion performance, anchorages were sprayed with zinc-aluminum pseudo alloy, and anchorage covers were filled with polyurethane resin to prevent infiltration of rainwater, etc.

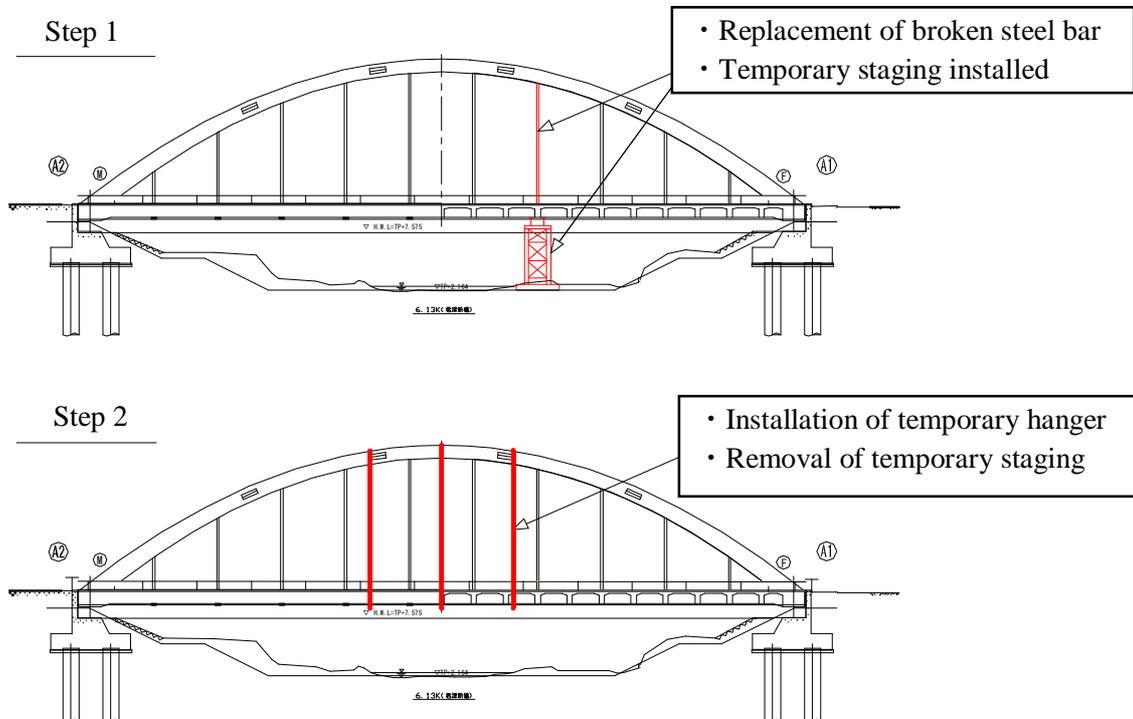
**Figure 3. Outline of emergency repairs**

The bridge has a structure with the deck slab supported by 40 steel bars from the arch ribs, so a breaking of a steel bar results in an excessive load on other steel bars and affects the structural integrity of the structure overall. Emergency repairs were performed in two steps to prevent bridge collapse or other serious situations in the event of breaking of other steel bars. The emergency repairs are illustrated in Figure 3.

Step 1 of the emergency repairs envisaged potential break of the steel bars adjacent to the broken steel bar. As a precautionary measure, a temporary staging was installed directly under the broken steel bar to support the deck slab of the bridge, and the broken steel bar was replaced. The existing coupler embedded in the deck slab was not corroded, so after testing its load capacity, it was reused when replacing the steel bar, connecting a new tendon to the coupler. The temporary staging was constructed by using large sandbags to make a coffer dam in the river, then assembling steel staging materials on a concrete foundation.

Step 2 of the emergency repairs consisted of temporarily installing 12 additional hanger with the objective of ensuring structural integrity and preventing the bridge from collapsing in the event of break of up to 24 of the steel bars, equivalent to 60% of the hanger. The structure of the temporary hanger consisted of steel support beams secured to the top surface of the arch ribs and to the bottom surface of the deck slab, with these beams linked by new steel bars. Out of consideration for the overall balance of the structure and in order to facilitate the work of hanger replacement at the permanent repair stage, these temporary members were positioned midway between existing hanger. It was necessary to drill through the deck slab to accommodate the additional steel bars. As there was a risk that drilling might damage nearby longitudinal PC cables or steel reinforcements, X-ray inspection and ground-penetrating radar were used to locate steel elements before starting work, and the drilling was performed cautiously to prevent damage. Installation of the temporary members made it possible to remove the temporary staging from the river, ensuring that the bridge would remain safe during the flood season.
