SCMT4
Las Vegas, USA, August 7-11, 2016

A Case Study of Strengthening of Distressed Prestressed Concrete Box-Girder Bridge

¹CSIR-Central Road Research Institute, Mathura Road, P.O. CRRI, New Delhi-110025, India.

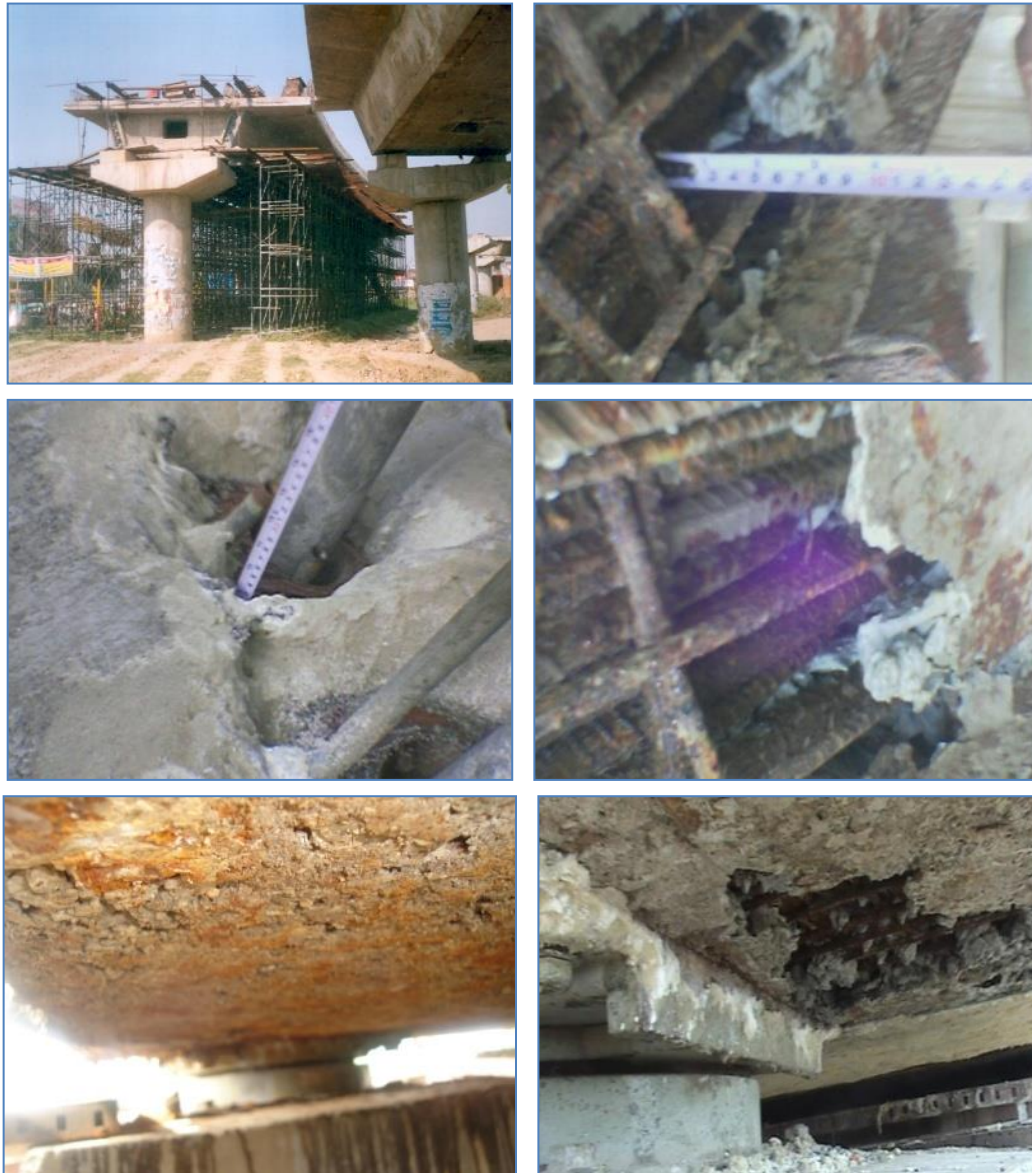
Figure 3. Views of Distressed Span P2-P3 on Outer Carriageway

exposure of steel reinforcement were observed in the soffit slab near the junctions of end-diaphragm walls and inclined web and in the vicinity of bearings (refer figure 3). Application of epoxy mortar and grout nipples in the affected areas was also noticed. Shuttering plates under the entire area of soffit slab except near end-diaphragm walls were still at place. Due to this reason, the concrete of soffit slab behind these shuttering plates could not be inspected.

- The reinforcement in the vicinity of bearing region was not spaced properly (bars butting each other) which has hindered in pouring of the concrete. The improper bar spacing and use of ungraded

aggregates had resulted to honeycombing and exposure of reinforcement in the vicinity of bearing, which was on the inner edge of Faizabad end was more than the bearing under the outer web. The same condition was observed on Sitapur end also. It was revealed that the bearing region of inner edge of both the supports had honeycombing. The depth of spalling of concrete in soffit slab was up to the level of second layer main reinforcement (20 mm dia) from bottom.

- Honeycombing and spalling of concrete with the reinforcement exposed was also noticed in the soffit slab, end diaphragm wall and the tapering bottom slab in a length of about 1.8-2.0 m.
- Schmidt rebound hammer test (refer figure 4), though not carried out on old concrete for assessment of concrete strength, yet with no other alternative available, it was used to roughly assess the in-situ concrete strength of the end diaphragm walls and the webs meet the requisite compressive strength criteria of 40 MPa except few locations where concrete was damaged or localized repair had been carried out. The quality of concrete falls in the category of 'Good' as obtained from the ultrasonic pulse velocity test (refer figure 5).

For overhead repairs (in the vicinity of bearings), shotcrete is ideal which uses almost half as much water as compared to conventional concrete. This low water-cement ratio and high density makes the shotcrete a high strength repair material.

Before carrying out shotcrete, loose concrete was removed. Wherever reinforcing bars were exposed, the concrete was removed from around the bars, to allow the repair mortar to properly bond to steel and

A good bond between old and new concrete was obtained by applying an epoxy bonding coat just before applying the shotcrete. A shotcrete in the ratio of 1: 2: 2 (cement: fine aggregate: coarse aggregate retained 4.75 mm size) with compressive strength not less than 40 MPa, was then applied with suitable pressure. The hardened surface of the freshly placed shotcrete layer was broomed or scarified and dampened before applying the next layer. Immediately after shotcreting, the repair surface was screeded for a flashcoat finish. The completed surfaces were cured. Wherever, the depth of spalled concrete was more than 75mm, a wire mesh was fixed before shotcreting.

In the honeycombed areas, epoxy injection grouting was recommended. Epoxy of low viscosity, non-shrinkable, high early strength and ultimate strength to not be less than the in-situ concrete strength, 40 MPa was used.

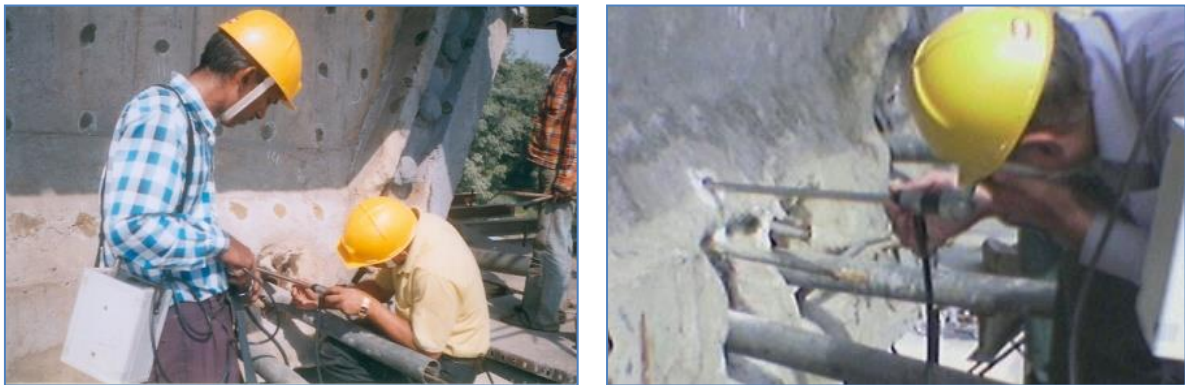
Figure 6. Examination of honeycombing through Boroscope around Anchorage zone

From the examination of honeycombing by Boroscope (refer figure 6), it was observed that there was honeycombing along the length of the ducts in the unstressed anchorages on both the ends. The extent of honeycombing in the anchorage zone, especially on the Faizabad end was found to a length of about 0.5m. This honeycombing in this zone was the main reason for failure of the anchorages during the prestressing. Therefore, the unstressed anchorages were in need of immediate repair before prestressing.

- The in-situ compressive strength of concrete in the investigated region meets the requisite strength and the overall quality of concrete falls in the category of ‘Good’.
- The anchorage zone of unstressed anchorages exhibited honeycombing and needed repair before prestressing.
- The soffit slab in the bearing region, where a large honeycombing and spalling of concrete was observed, also demanded repair.

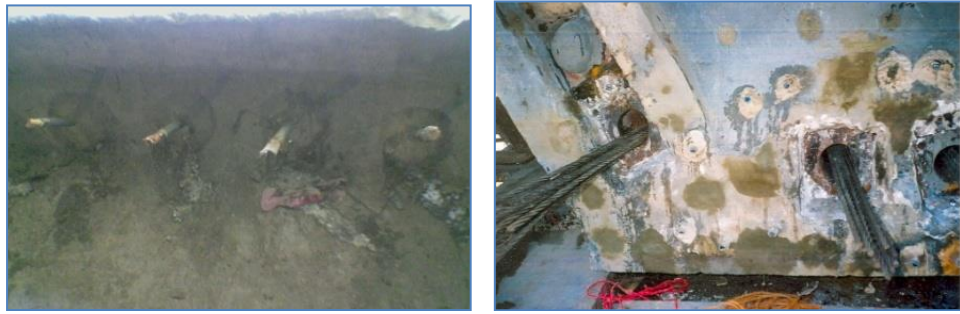
Figure 7. View of the Span after Repairs

The spalled concrete in the anchorage zone and vicinity of bearing area, soffit slab and both the end diaphragms of span P2-P3 was repaired using the shotcrete technique. Epoxy injection grouting was carried out in the honeycombed areas by fixing nozzles around anchorage zones, diaphragm walls, inclined webs, soffit slabs of diaphragm walls and the portions underneath the soffit slab. Figure 7 shows the typical views of the span after these repairs.

The in-situ surface strength (representative) of the shotcreted region was determined by using Schmidt rebound hammer test after about one week of its application. From this test, average compressive strength of concrete was found to be 16.90 and 26.77 MPa at the bottom of soffit slabs at Sitapur and Faizabad end respectively which was lower than the target strength of 40 MPa at 28 days. After 28 days, compressive strength was tested by UP PWD and was found to be more than the target strength. No signs of honeycombing were traced in boroscope study near the anchorage zones.

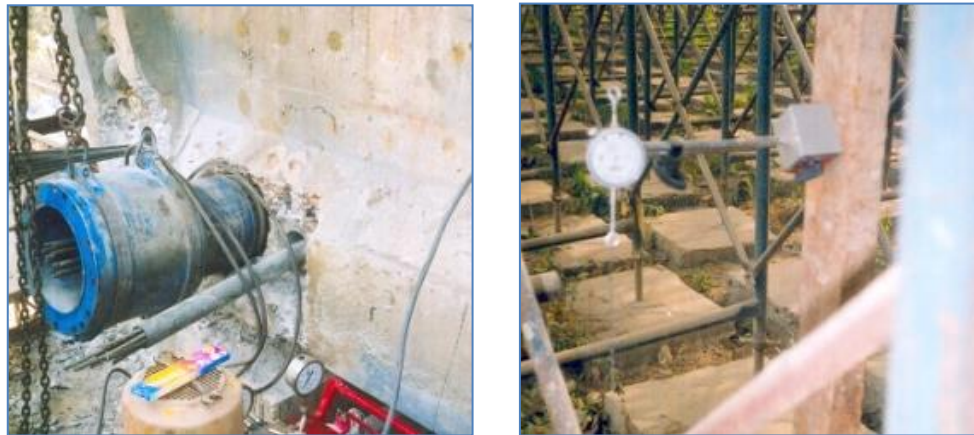
Figure 8. Deflection Measurements of the Span during Prestressing of Tendons

After being satisfied with the results of non-destructive testing, remaining five prestressing tendons (four in soffit slab and one in web) were stressed successfully in December 2007 to the requisite level of stressing without any punching of concrete in the anchorage region. During prestressing of the remaining five prestressing cables, mid-span deflections of the span were also monitored (figure 8) to observe post repair behaviour of the bridge. Upward deflections were noticed with the stressing of the prestressing cables, indicating the satisfactory effectiveness of the repairs. After the removal of shuttering plates, observed spalled and honeycombed concrete was repaired using the methodology given earlier.

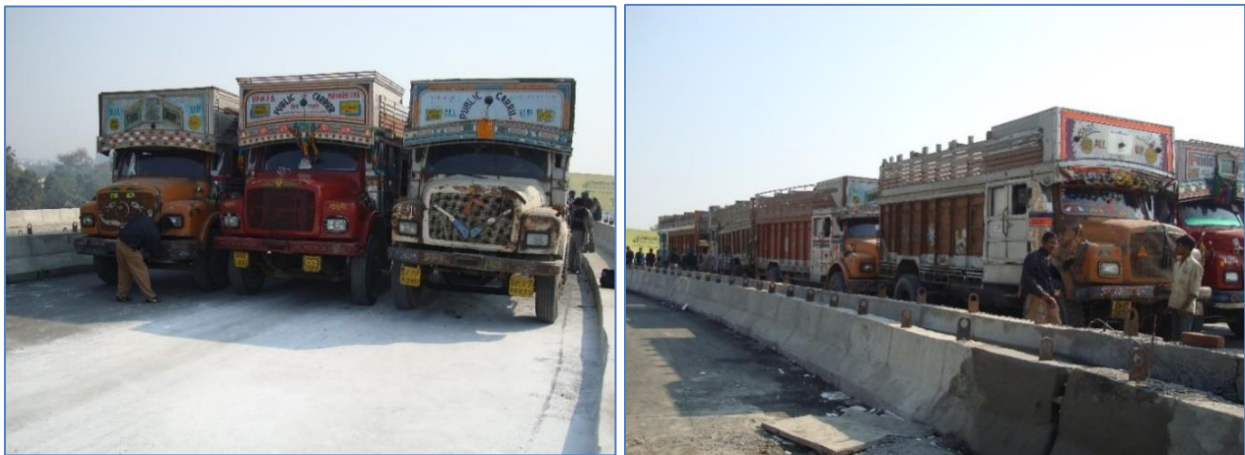
Figure 9. Placement of trucks over the span

Ideally the load testing should have been done through platform loading as specified in SP-51-1999. However, due to limited available time for load testing, the loading has been applied through twelve numbers of standard configuration trucks (TATA 1608 model with 4.2m c/c axle spacing). The Gross Vehicle Weight (GVW) of each truck was 15T. The total loading has been applied in five stages, placed in ascending order viz., 25% of loading represented by 3 nos. of trucks; 50% of loading represented by 6 nos. of trucks; 70% of loading represented by 8 nos. of trucks; 90% of loading represented by 10 nos. of trucks and finally 100% of loading represented by 12 nos. of trucks. These trucks were kept stationary over the span for next 24 hours. The unloading operation has been done in the similar pattern as of loading operation in descending order, i.e., 90%, 70%, 50%, 25% and 0%. Figure 9 shows the typical views of the placement of the trucks over the span during load testing.

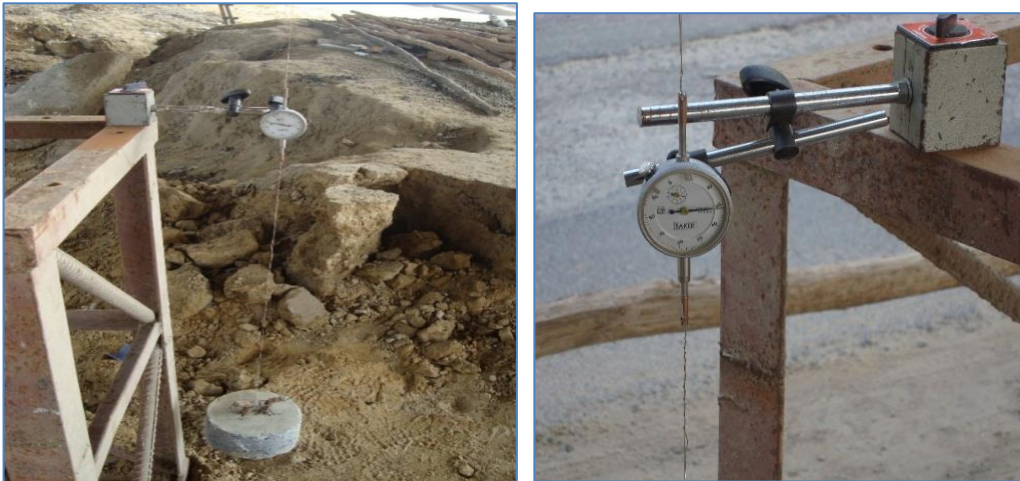
Figure 10. Typical arrangements for deflection measurement showing Dial gauge with suspended wire

The deflection parameter is the basic parameters in any load testing and acceptability of the structure depends upon behaviour of the bridge superstructure at working load in elastic range. The deflections at mid-span and quarter-spans were monitored along the length and width of box girder (near edges of cantilevers and centre of box). Thus, total nine numbers of points were monitored in each span using dial gauges with 0.001mm least count. Suspended wire method (figure 10) was used for deflection measurement.

Prior to commencement of load testing, the deflections of the span were recorded for 24 hours without any load over the span, due to change in atmospheric temperature. During load testing, the loads (truck load) were placed in an eccentric fashion (400mm from the edge of footpath) so as to produce maximum bending moment for the desired configuration of live loads. Deflection measurements with the help of dial gages were recorded for each stage of loading. After final stage (100%) of loading, deflections were monitored for next 24 hours. After 24 hours of full stage loading, the removal of load was initiated and carried out in same sequence and deflections were observed for their recovery at each stage. After the complete removal of all loads from the deck, deflections were again recorded on hourly basis for next 24 hours. Deflections of the span after applying temperature corrections are given in Table-2. It is observed that the net deflection remained within the theoretical values and much lower than the maximum allowable deflection, i.e., $L/1500$ as per IRC: SP-37. The percentage recovery of deflection of the span was also within the acceptance criteria, i.e., more than 85% as per IRC: SP-51. The displacement/rotation of bearings was also much below the allowable values under the static load test.

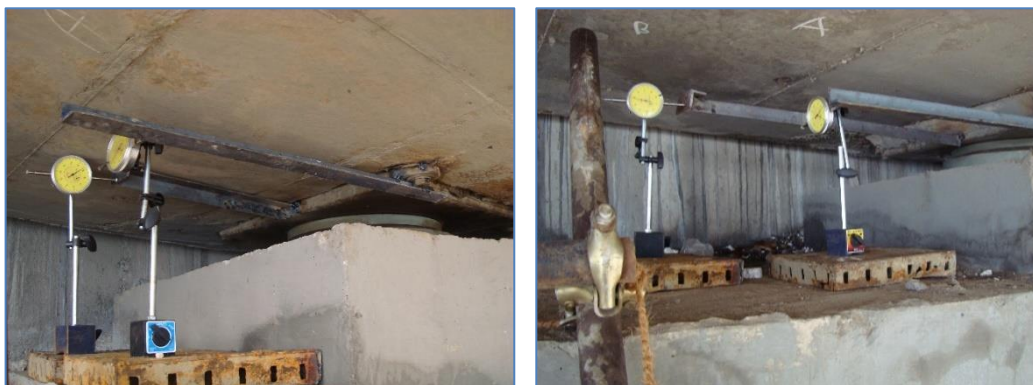
Figure 11. Placement of dial gauges for longitudinal and transverse movement of Free Type bearing

In addition to monitoring of the deflection of the span, displacement/rotation of bearings were also monitored through dial gauges. A special attachment was fabricated to record the above measurements as shown in figure 11.
