Embedded Sensors for the Monitoring Of Durability in Spain

I. Martínez, C. Andrade, A. Castillo, N. Rebolledo, and R. D'Andrea

*Instituto de Ciencias de la Construcción Eduardo Torroja (CSIC). C/Serrano Galvache nº4.
28033, Madrid, Spain. Email <isabelms@ietcc.csic.es>*

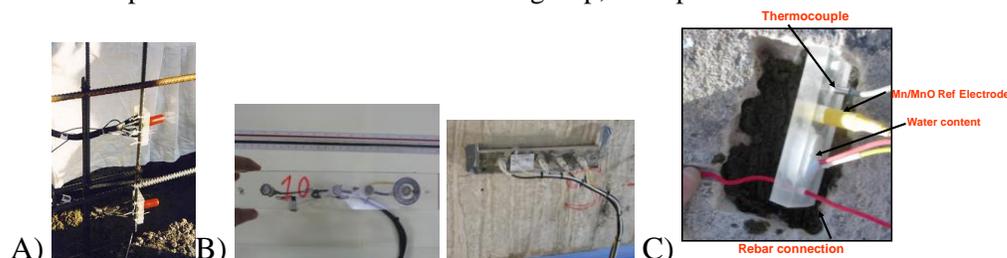
The type of embedded sensors used can be observed in Fig. 1. Depending on the structure in which they are going to be installed (new structures or existing structures), different group of sensors able to be attached to the concrete surface or embedded inside the concrete cover have been designed [Martínez and Andrade 2009].

Fig. 1. A) Embedded sensors for electrochemical measurements installed in a dock in the south of Spain. B) Surface sensors installed inside a bridge. C) Passive sensors installed in Zarzuela Racecourse.

Each group of sensors installed is composed by different electrochemical sensors or electrodes depending on the parameter to be measured. In one hand some sensors, as are the ones needed to evaluate corrosion rate or concrete resistivity, need an electrical impulse to be activated (active sensors). These sensors need to be connected to an electrochemical device (galvanostat-potentiostat) able to apply the signal and to record the sensor response. A stainless steel disk electrode is commonly used as counter electrode for the injection of the electrical signal in the corrosion rate and resistivity measurements. For the measurement of the corrosion rate, potential attenuation method [Feliú et al 1996] is the most useful to be used with permanent sensors. For these measurements, the sensor shown in Fig. 1B is used.

On the other hand there are other sensors (passive sensors), which don't need any impulse or electrical activation, and the parameter can be recorded directly through a data-logger. This is the case of corrosion potential sensors or water content sensors, which measure the difference of potential between the rebar and a reference electrode (in the case of corrosion potential sensors), or the potential variation between two metals embedded in mortar (water content determination). Ti, Mn/MnO₂, Ag and Pb are the most used reference electrodes for the corrosion potential evaluation. In the sensor group, a temperature sensor is also installed.

The structures whose results are presented are: 1) a bridge in the south part of Spain (the sensors installed are shown in Fig. 1.B). 2) A loading platform in a harbor in the south of Spain (sensors of Fig. 1A). 3) A Spanish pilot container for radioactive waste storage (structure shown in Fig. 5). 4) The Zarzuela Racecourse in Madrid, structure designed by E. Torroja in 1934 (sensors of Fig. 1C).

Electrochemical sensors able to indicate the risk of corrosion of reinforcement were installed in the decks and in the ties (Fig. 1C). These sensors enable the monitoring of the water content and the corrosion potential, in order to predict the need of maintenance interventions. As an example, some of the first results obtained are presented in Fig. 10.

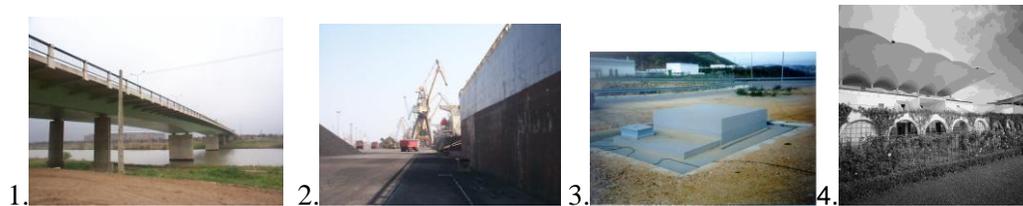
Fig. 2. Examples of structures monitored in Spain.

The bridge (Fig. 2.1) has a post-tensioned deck with a metallic girder. The concrete was contaminated with chlorides during mixing due to salt in the mixing water. Due to this contamination, corrosion started in the bridge from its casting. Sensors were installed in order to monitor 32 points near the four piles of the bridge. The results of some of the sensors are shown in Fig. 3, in which temperature, corrosion potential, corrosion rate and resistivity parameters are monitored. It can be noticed that due to the presence of chloride in some parts of the bridge, corrosion rate values higher than $0.2 \mu\text{A}/\text{cm}^2$ are detected.

The harbor structure (Fig. 2.2) was a hollow cube in a dock of around 30 m side. 14 groups of sensors were embedded during the construction at different dept, as Fig. 4 shows. As could be expected in an underwater structure, in which the concrete pores are almost saturated with salt water, resistivity values are lower than $10\text{K}\Omega\text{cm}$. Even when the resistivity is so low, the results show no corrosion, however, the values of E_{corr} in this structure are not easy to interpret due to the saturated condition.

A particular example of the use of embedded sensors is the case of storage facilities of low and medium radioactive wastes in El Cabril (Córdoba) (Fig. 2.3) [Andrade et al 2006]. There, a pilot reinforcement container has been instrumented from 1995 by embedding 27 set of electrodes. The parameters controlled are: temperature, concrete deformation, corrosion

The three decks of the structure are considered an art in terms of engineering. It is formed by thin concrete sheets of a hyperboloid shape with variable thickness between 65 cm in the area of pillars and 6 cm at the edges, supported up by a single pillar as cantilever to 13 m high. That is possible thanks to intelligent intertwined armed design and installation of steel bracing liabilities (Fig. 2.4).

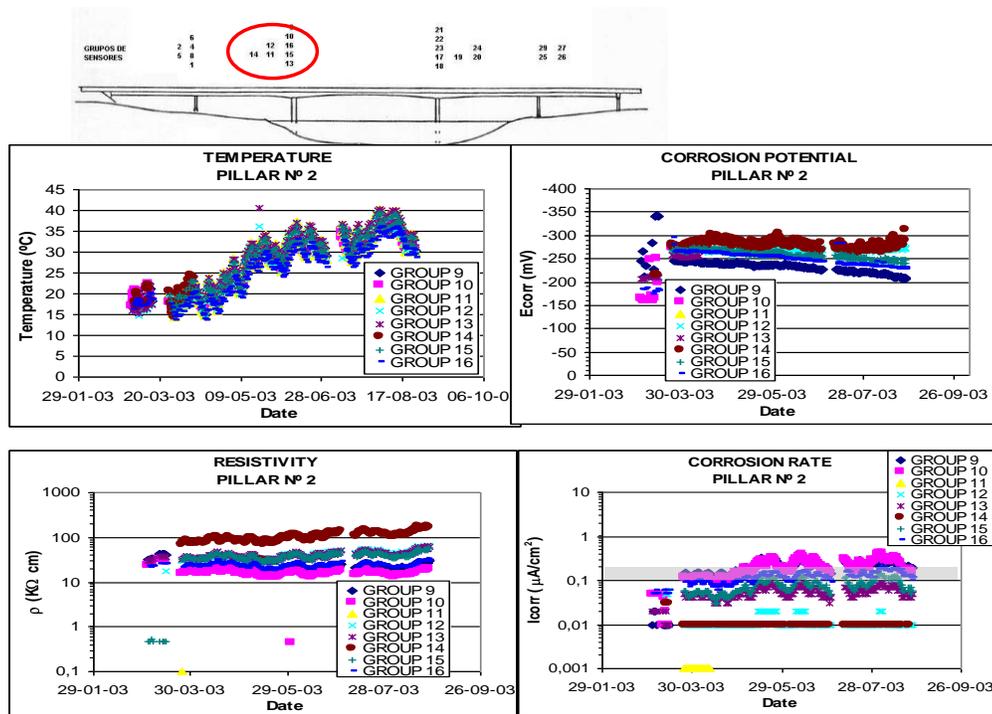
Fig. 3. Results obtained through corrosion surface sensors installed inside a bridge.

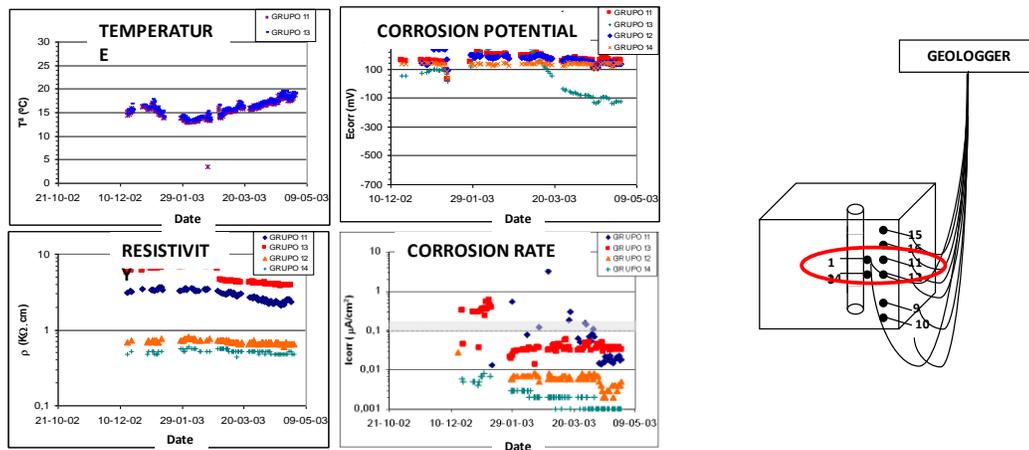
Groups 11, 12, 13 Y 14

Fig. 4. Results obtained in the harbour situated in the south part of Spain

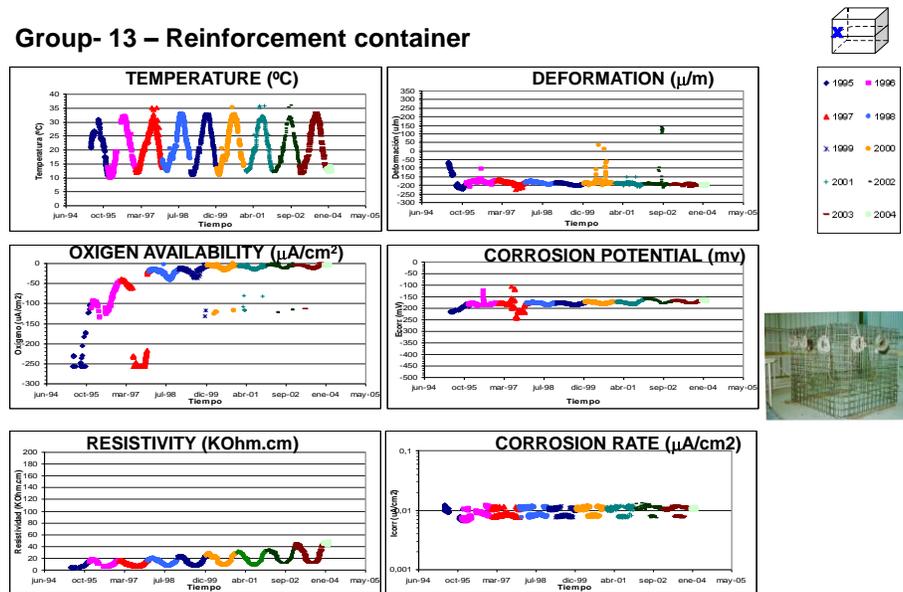
Group- 13 – Reinforcement container

Fig. 5. Parameters registered on the concrete pilot container since 1995 to 2004.

Regarding the resistivity, it is measured by means of the current interruption method from a galvanostatic pulse. The oxygen flow at the rebar level is measured by applying a cathodic constant potential of about -750 mV (SCE) and measuring the current of reduction of oxygen. From the 27 groups of sensors installed, only less than 10% of them have failed. The rest show a good response even ten years after their installation. As an example, Fig. 5 depicts the results obtained from one group of sensors placed in one wall of the concrete container (group 13). The reinforcement remains passive as expected ($I_{corr} < 0.1 \mu\text{A}/\text{cm}^2$).

The recording during 10 years has enabled several deductions among which can be stressed that the temperature influences very much the responses of the sensors and that a progressive decrease of the amount of oxygen is detected without being this noticed by the values of the corrosion potential. The progression of hydration is well reflected by the electrical resistivity and the strains are very good detectors of the presence of water in liquid state.

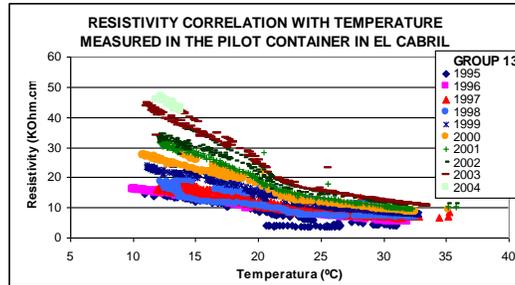
Fig. 6. Correlation between resistivity and temperature measured in buried conditions

As an example among the 27 groups of sensors, Fig. 6 shows the correlation between resistivity and temperature of Group 13, and how it changes with time. It is clear that this relation is different at temperatures below around 22°C and at higher temperatures.

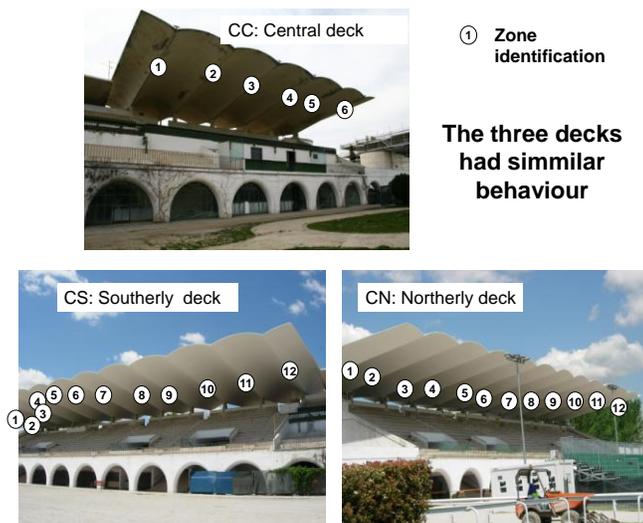
Fig. 7. Different zones evaluated in the three decks.

The corrosion rate (evaluated by the modulated confinement method by means of the corrosion rate meter Gecor 08 [Feliú et al 1990] [Andrade and Martínez 2005]) was quantified in different areas of the three decks (Fig. 7). The results indicate that almost all the structure is corroding due to the concrete carbonation. The majority of the values registered are in the range of moderate corrosion rates (between 0.5 and 1 $\mu\text{A}/\text{cm}^2$), as is shown in the example of Fig. 8b.

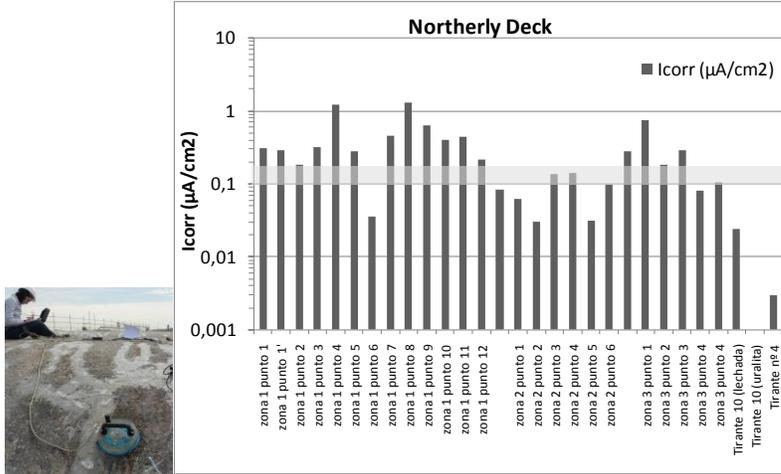
Fig. 8. Left: Sensor and device used for the corrosion rate measurements. Right: I_{corr} values registered in the northerly deck.

Considering the importance of this building, the authorities decided to undertake a restoration project where it is contemplated the installation of a continuous monitoring system. After removing all the paint in the lower part and the waterproofing in the upper part of the decks by water under pressure, an assessment of the extent of corrosion was required. It was possible to measure the carbonation front, and to apply a non-destructive electrochemical method based on the polarization resistance technique to verify the corrosion rate (Fig. 8a).

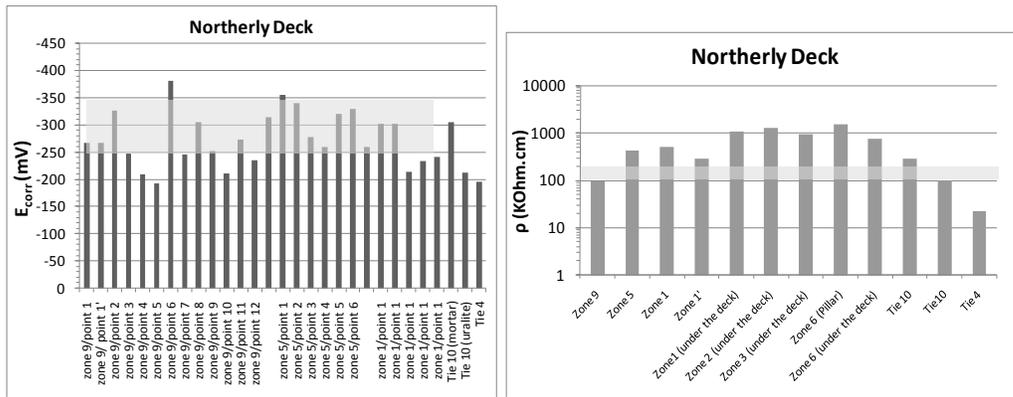
Fig. 9. E_{corr} and resistivity results obtained in the northerly deck.

Other corrosion indicators, as are the corrosion potential and the resistivity, were also evaluated. E_{corr} was measured with a Cu/CuSO₄ reference electrode. The majority of the

values measured were in the range between -250 and -350 mV, what means an intermediate corrosion risk [ASTM C876-91]. Talking about concrete resistivity, very high values (higher than 200 KΩ.cm) were measured. These high values are due to the delaminations and voids present in the concrete, which do not allow a properly electrolytic contact for the measurement. For this reason, they do not correspond with the real concrete cover resistivity.

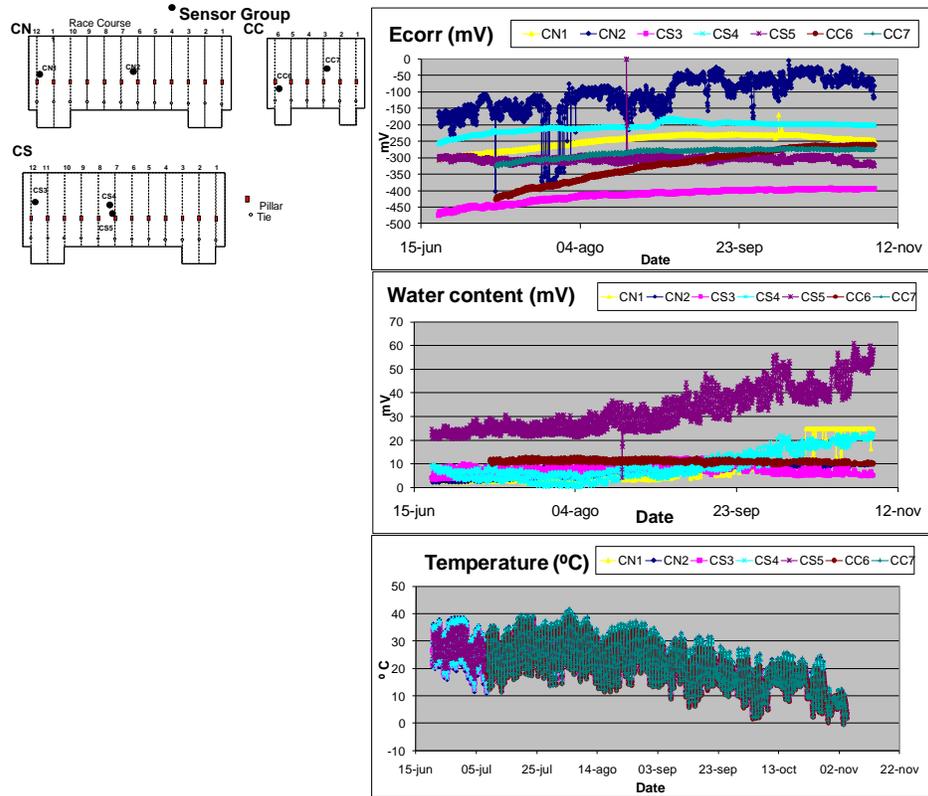
Fig. 10. Some of the results obtained from the embedded sensors

The E_{corr} tend to less negative values with time what means that the steel is being passivated. In the case of water content sensors, the response is measured in mV (difference of potential between two metals embedded in the sensor). Values around 0mV means no liquid water, so, the new waterproofing system is working properly
All the temperature sensors have the same behavior and the correlation of the temperature with the electrochemical parameters is now under study.
