Corrosion of Cement Paste Coated Steel Bars in Marine Environment

Mohammed Tarek Uddin^{1,*}, Hidenori Hamada², Mohammed Abdullah Al Mamun³, and Ariful Hasnat⁴

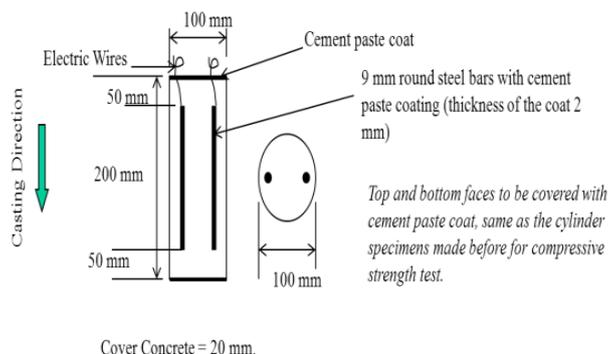
Figure 1. Layout of the specimen

Mixture proportions of concrete are summarized in Table 4. W/C was 0.5. Mixing water was potable tap water. Twenty-two cases were investigated. Concrete for each specimen was same and follows the mixture proportion summarizes in Table 4. The layout of the specimens

is shown in Figure 1. The length of the steel bars was 100 mm and 9 mm in diameter. Two round steel bars were placed at cover depth of 20 mm. Electric wires were connected with the steel bars and a cement paste coat of 0.25 mm thick was applied over the steel bars before embedding the steel bars inside concrete as shown in Figure 2. Variations of steel-concrete interface (denoted by C1~C22) were introduced by different types of cement, different W/C ratio, and different type of water. Ordinary portland cement, slag cement Type B (SCB, slag content varied from 30%~60%), slag cement Type C (SCC, slag content >60%), fly ash cement Type B (FACB, fly ash content 10%~20%), alumina cement, ordinary portland cement with silica fume, and ordinary portland cement with metakaoline were used for coating over steel bars. The properties of these materials are shown in Table 5. Tap water and seawater was used as mixing water. Tap water was used for all cases and seawater was used for alumina cement only. Preparation of cement paste is shown in Figure 3. After preparation of the cement paste, steel bars were submerged into the cement paste and carefully removed so that a layer of cement paste is formed over the steel bar. Then steel bars were hanged as shown in Figure 4 in a humid room. Then steel bars were hanged into the mold and then concrete was casted accordingly. The details of twenty-two cases are summarized in Table 6. Three types of concrete were used based on compaction procedure and slump value. These are noted as CON1, CON2, and CON3. In CON1, compaction was done by using a vibrator. In CON2, compaction was done by temping rod only. In CON3, a relatively low slump concrete was used and compaction was done by temping rod only. Cases related to the variation of steel-concrete interface denoted as C1 to C16 were made with CON1, and C17~C19 were made with CON2, and C20~C22 were made with CON3, respectively. After standard curing of 28 days, to accelerate the chloride ingress into concrete, the specimens were submerged in seawater of temperature 60°C for 3.5 days and then air-dried for 3.5 days under atmospheric temperature. During drying process, air circulation was provided by the electric fans. Natural seawater was used and its chemical and physical properties are given in Table 7.

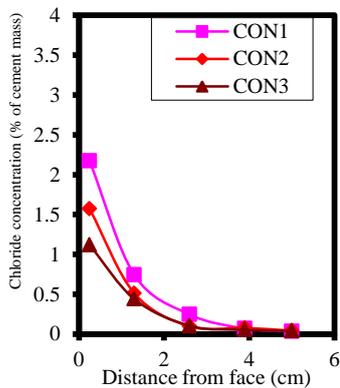
Figure 5. WS Cl⁻ concentration at 10 cycles

Water soluble chloride concentration as % of cement mass at 10, 20, and 45 cycles of exposure are shown in Figure 5, Figure 6, and Figure 7 respectively for CON1, CON2, and CON3. Chloride threshold limit is generally defined at 0.4% of cement mass (RILEM, 1988). For all cases, chloride concentration into concrete is increased with time. Maximum chloride ingress into concrete is found for the case with low slump concrete and compaction

by rodding only. It is expected due to the presence of more capillary channels in concrete compacted by rodding only. The state of corrosion of steel bars inside concrete is explained below with respect to the chloride concentration around steel bars.

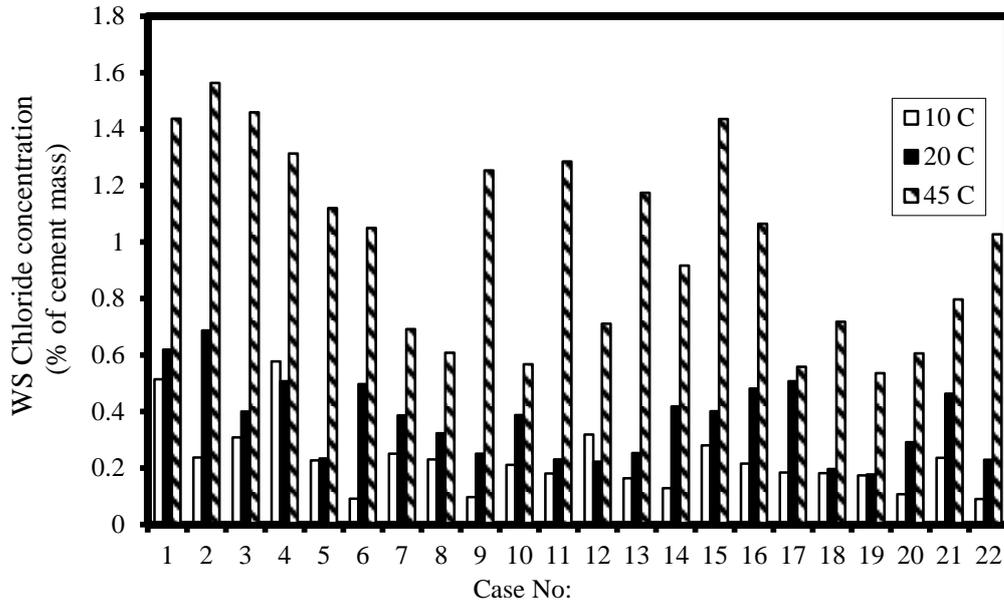
Figure 8. WS Cl⁻ concentration at 10C, 20C, 45C

Water soluble chloride concentrations around the steel bar are shown in Figure 8. The samples were collected from a distance 5 mm around the steel bars. After 10 cycles of exposure, it is found that chloride concentration of each case is below the chloride threshold level except for C1 and C4. After 20 cycles of exposure, it is found that chloride concentration around steel bar crosses the chloride threshold limit for C1-C4, C6, C7, C10, C14, C15 - C17, and C21. Mineral admixtures were used to make coat over the steel bars for C6-C8, and C13-C16. A dense steel-concrete interface is formed around the steel bars for these cases, which prevent steel bars from corrosion even for high chloride content. This is explained later.

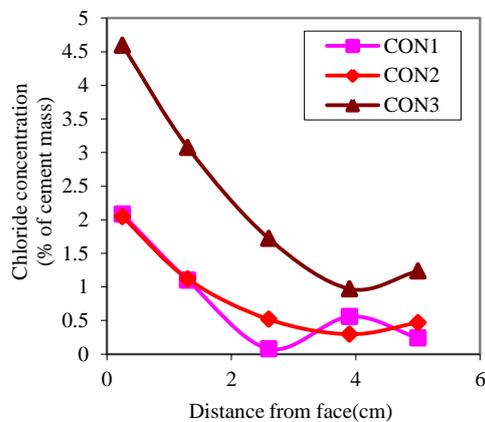
Figure 9. AS Cl⁻ concentration at 45 cycles

Acid soluble chloride concentration as % of cement mass at 45 cycles of exposure is shown in Figure 9 for CON1, CON2, and CON3. Same as water soluble chloride, more ingress of acid soluble chloride concentration is found for the cases with low slump concrete and compaction with rodding only.

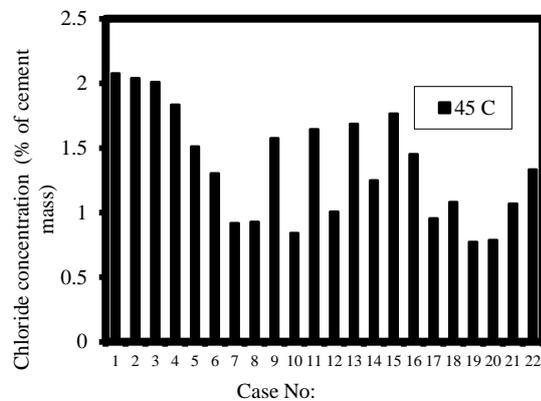
Figure 10. AS Cl⁻ concentration at 45 cycles

Acid soluble chloride concentrations for all cases around the steel bar are shown in Figure 10. Acid soluble chloride concentration around steel bar exceeds 0.75% of cement mass irrespective of all cases. However, relatively less amount of chloride is found for the cases coated with a low W/C.

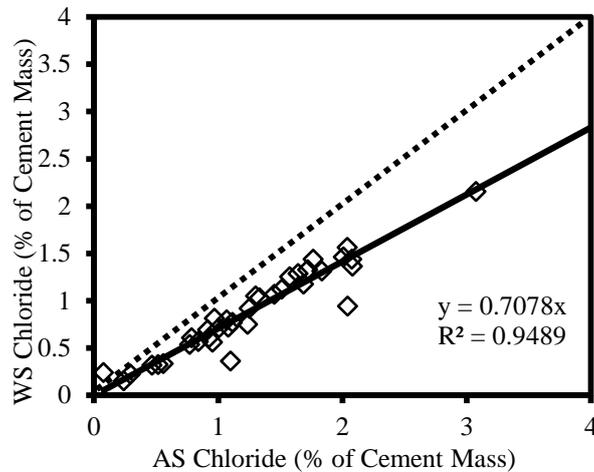
Figure 11. Water soluble Cl⁻ concentration VS acid soluble Cl⁻

Variation of water-soluble chloride concentration and acid soluble chloride concentration is shown in Figure 11. The following relationship is found between water-soluble (WS) chloride concentration and acid-soluble (AS) chloride concentration.

$$Y = 0.708 \times X \quad (2)$$

where, Y is the water-soluble chloride concentration in % of cement mass and X is the acid soluble chloride concentration in % of cement mass.

$$\text{Water soluble chloride concentration} = .708 \times \text{Acid Soluble Chloride Concentration}$$

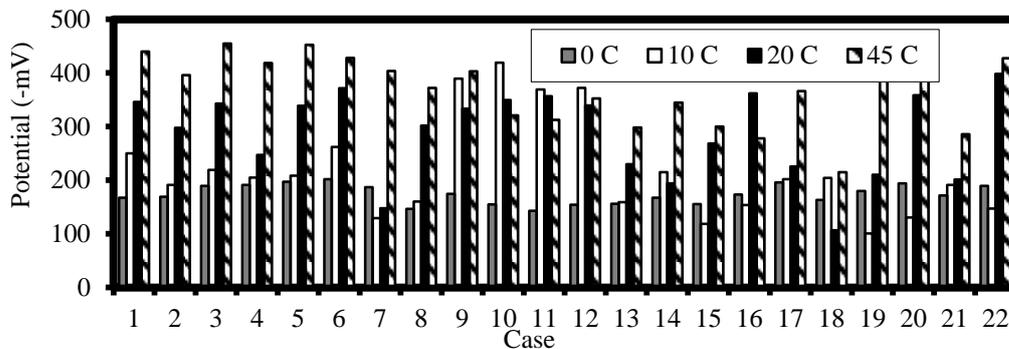
Figure 12. Half-cell potential at 0C, 10C, 20C, 45C

Half-cell potential (HCP) over the steel bars is shown in Figure 12. The threshold limit of half-cell potential is assumed to be -230 mV (versus Ag/ AgCl) (ASTM C876, 1991). The half-cell potential before accelerated exposure was higher than -230 mV for all cases. After 10 cycles of exposure, C1, C6, C9, C10, C11, and C12 show the most negative half-cell potential compared to the others. For C1, no coating was applied. For C6, slag cement of Type B (SCB) was used to make coating over steel bar with W/C=0.5. For C9, C10, C11, and C12, alumina cement was used to make coat over steel bars. After 45 cycles of exposure all cases show lower negative potential than threshold limit of -230 mV except for C18, where the steel bars were coated with cement paste of ordinary portland cement (OPC) with a W/C ratio of 0.3 and C3 shows most negative potential, where the steel bars were coated with cement paste of ordinary Portland cement (OPC) with W/C ratio of 0.5.

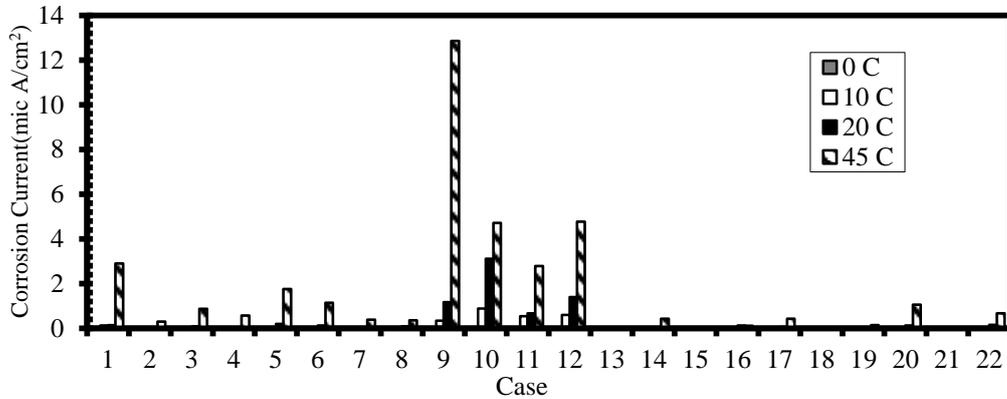
Figure13. Micro-cell corrosion at 0C, 10C, 20C, 45C

The micro-cell corrosion current density of the steel bars is shown in Figure 13. Generally, the passivity limit is defined at a corrosion current density of $0.1 \mu\text{A}/\text{cm}^2$ (Andrade and Alonso, 2000). Before accelerated marine exposure, the corrosion current density was negligible. After 10 cycles of exposure, it was found that C1, C9, C10, C11, and C12 show corrosion current density over $0.1 \mu\text{A}/\text{cm}^2$. No coating was applied for C1. For C9, C10, C11, and C12, alumina cement paste coat was applied over the steel bar. After 20 cycles of exposure C9, C10, C11, and C12 show high amount of corrosion current density, also C1, C5, C6, C16 and C22 showed relatively more corrosion current density. After 45 cycles of exposure, same as the previous cycles C9, C10, C11, and C12 showed remarkably high amount of corrosion current density. Also other cases showed corrosion current density above passivity limit except for C13, C15, C18, and C21 for which the steel bars were coated with a low W/C, except the cases with alumina cement. The reason for more corrosion over the steel bar coated with alumina cement is due to the following conversion of hydration products:

The conversion reactions liberate water molecules and create more voids around the steel bar. For this reason, C9, C10, C11, and C12 showed more corrosion. Both seawater and tap water were used for making cement paste with alumina cement (Table 6). Both cases showed significant amount of corrosion over the steel bars.

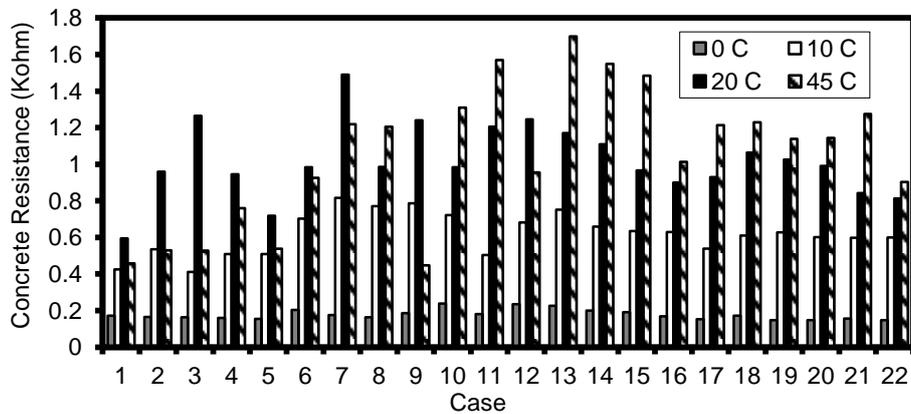
Figure14. Concrete resistance (Rc) at 0C, 10C, 20C, 45C

Concrete resistances over the steel bar is shown in Figure 14. Before accelerated marine exposure (zero cycle), more concrete resistance over the steel bar is found for the cases for which cement-paste coating was applied over steel with a low W/C. No significant reduction of concrete resistance was found for C9, C10, C11, and C12. However, these cases showed more corrosion current density over the steel bars due to conversion reactions of hydration products as explained earlier.

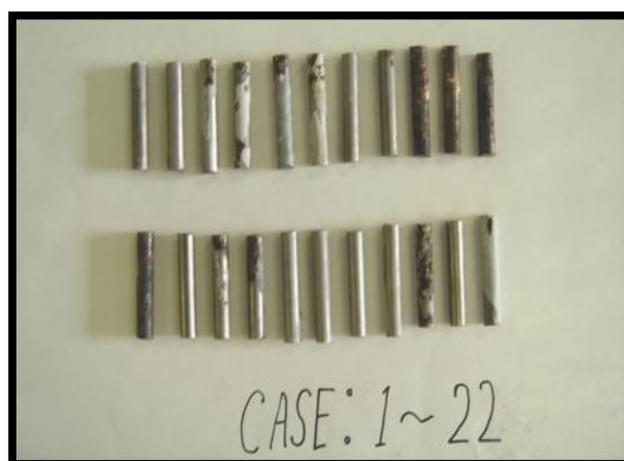
Figure 15. Visual observation after split the specimen and before removing the paste (45 cycle)

After electrochemical investigations, the specimens were split opened to see the condition of the steel bars as well as the split opened concrete surface surrounding the steel bars. The results of physical evaluation of corrosion of the specimens at 10 cycles, 20 cycles, and 45 cycles are summarized in Table 9. The surface condition of the steel bars before and after removal of cement paste coating at 45 cycles is shown in Figure 15 and Figure 16. After 10 cycles, corrosion was found for C9, C10, C11, and C12. Rust spots were found for C6, C7, C8, C15, and C16. Whitish surface were found for other cases. After 20 cycles of exposure, it was found that C9, C10, C11, and C12 were corroded by 70%, 90%, 30%, and 60% of total surface area of steel bars, respectively. Some spots were found in C2 (2 spots), C4 (4 spots), C7 (1 spot), C8 (9 spot), C15 (1 spot), C16 (1 spot). For C5, corroded area over the steel bar was 0.5 cm². But no corrosion was found for C1, C3, C6, C13, C14, and C17~22. After 45 cycles of exposure it was found that steel bar of C9, C10, C11, C12 were fully corroded where alumina cement were used to make paste. C4, C5, C6, C8, C14, C15, C18, C19, C20, C21, and C22 were corroded by 14.4%, 13.6%, 18.1%, 3.8%, 11.1%, 10.5%, 0.6%, 0.3%, 45.1%, 0.9%, and 1.7% of total surface area of steel bar, respectively. No corrosion was found for the cases for which steel bars were coated with a low W/C.

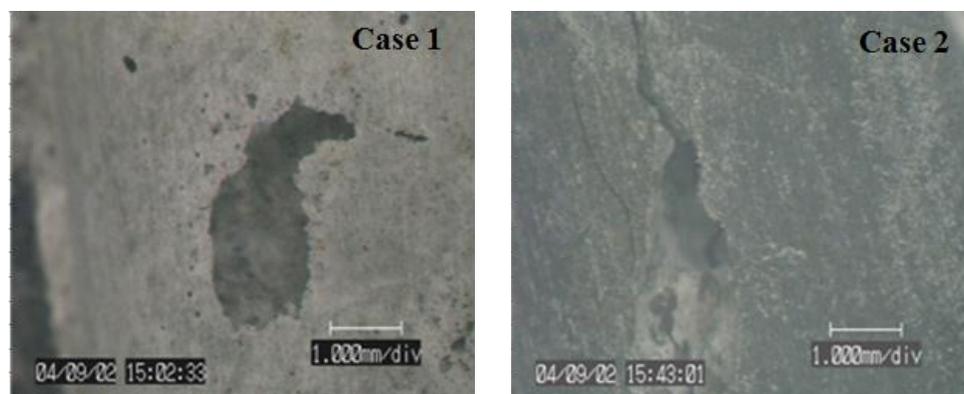
Figure 17(a). Steel-concrete interface under optical microscope (1-2)

To clarify the nature of the steel-concrete interface, optical microscope investigation on the steel-concrete interface was extensively carried out on the split-opened surface surrounding the steel bars. The split opened surface surrounding the steel bars for different cases are shown in **Figure 17**. Presence of voids was found for the uncoated steel bars, steel bars coated with a high W/C, and steel bars coated with alumina cement. These voids cause corrosion over the steel bars. It is clearly understood that the physical nature of the steel-concrete interface in concrete is very important to initiate corrosion over the steel bars.

Optical microscope investigation was carried out for largest void, small voids, rusted interface, and cracked interface. Large void was found in all cases and also a lot of small voids were found at the steel-concrete interface for all cases.
