Long Term Performance of Cathodic Protection Applied on Deteriorated PC Girder Specimen due to Chloride Ingress

ABSTRACT

In this study, long term performance of cathodic protection (here in after CP) was evaluated using actual PC girder which had deteriorated due to chloride ingress before the application. We have used two different types of anode in CP system by dividing the specimen into some parts. In order to investigate the influence of oversupply of current on hydrogen embrittlement of PC wires, 6 times more than normal current was supplied in some part of specimen. During the operation period, the specimen has been exposed in actual marine environment. After 10 years operation period, cover concrete was removed, conditions of PC wires in part of specimen and durability of pipes for CP system were examined. As a result, we confirmed that both anodes have long term performance to prevent the corrosion progress of PC wires in marine environment, without any risks of hydrogen embrittlement even in oversupplied current follow condition.

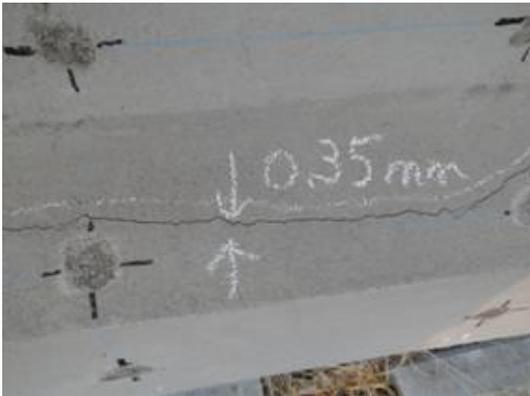
Photograph 1. Crack of Over-lay Mortar (TM system : normal protective)

From the visual inspection on TG system area after application, cracks were found in joint mortar. In TM system, micro hexagonal pattern cracks were observed on the surface of the over-lay mortar. Especially, in sea side flange where TM system with normal protective level has been applied, crack was generated along the PC wire and its width was about 0.35mm, as shown in Photograph 1.

PC wires taken out from the part of TG and TM system (normal protective level) after CP application are shown in Photograph 2 and 3. Comparing the appearance of those PC wires with those before application, it can be confirmed that corrosion progress has been kept in the same level during operation period. . Therefore, it was thought that the drying shrinkage of mortar is a main cause of those cracks, except large crack in Photograph 1 which occurred due to the crack opening in the base concrete.

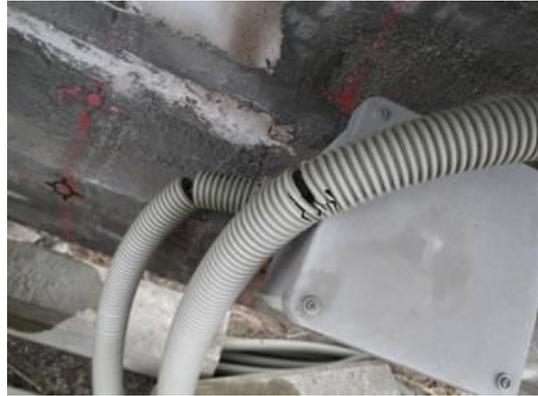
Photograph. 4 Condition of Pipes (after 10 years)

Photograph 4 shows pipes after 10 years operation. In this exposed condition, some pipes received direct sunshine every day; therefore, pipes made of the resin caused some cracks due to ultraviolet deterioration. For the application of CP system, it is very important to consider the suitable arrangement and orientation for pipes to avoid the deterioration due to ultraviolet ray.

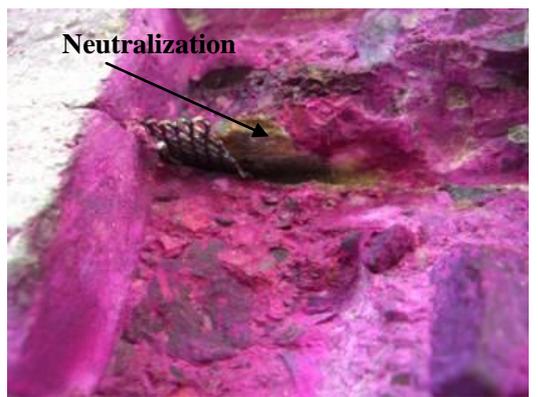
Photograph 5. Mortar around Anode (TG system : after 10 years)

Soundness of anode system. Neutralization depths of mortar around anodes in TG and TM system are shown in Photograph 5 and 6. Around both anodes, neutralization depth was approximately 1mm. It caused because of electrochemical reaction occurred around anode surface. However, we evaluated that the anode system was sound after 10 years operation, because the supplied condition and the effect of corrosion protection were still active. Figure 12 shows the result of the NACE standard accelerated life test. For both anodes, same
