SCMT4
Las Vegas, USA, August 7-11, 2016

Freezing Damage Mechanism in Model Microchannels and Vacuum Curing on Cement Paste to Improve Frost Damage Resistance

Yuya Sakai^{1a}, Tomohisa Kamada^{1b}, and Toshiharu Kishi^{1c}

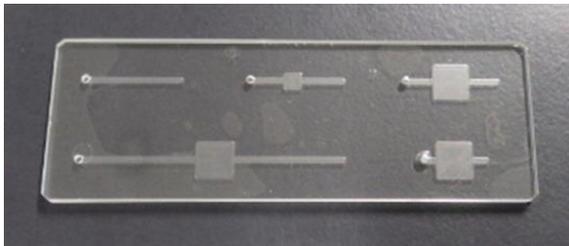
Fabrication. Microchips (Photo 1) were fabricated with glass slides (soda lime glass, $76 \times 26 \times 1.3$ mm). One microchip was composed of two slides; microchannels were milled on one slide and holes of 1 mm in diameter were made on another slide. The machining was done with an NC processing machine. The two machined glass slides were cleaned with pure water and a melamine sponge, and immersed into solution of one part hydrogen peroxide to three parts sulfuric acid. The slides were rinsed with pure water, dried with duster spray, and pressed against each other to adhere by hydrogen bond. The bonded glass slides were baked at 645°C for 5 hours and cooled slowly. The slides were bonded to each other with enough strength to undergo punching failure rather than detachment from each other when water in the channels was frozen. Each microchip contained five microchannels with different geometries to study the effect of channel shape and size on frost damage. Basic designs of the five microchannels are shown in figure 1. One channel had a straight profile and the remaining four had ink bottle profiles with different cavity areas and neck lengths. All channels had a depth of $500\ \mu\text{m}$ and the straight channel and necks of ink bottle channels had a width of $1000\ \mu\text{m}$. The dimensions of the cavities are shown in figure 1. After machining the glass slides, the dimensions of the channels were confirmed using a surface roughness tester. Additionally, in some experiments, microchips containing microchannels with widths and depths of $500\ \mu\text{m}$ and $250\ \mu\text{m}$ were used. Lastly, in some experiments, microchips had similar geometries to those found in figure 1 but contained only inlets, and no outlets.

Photo 1. Fabricated microchip

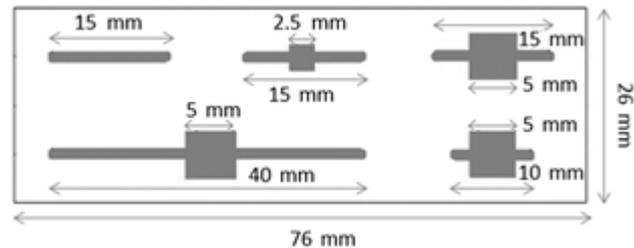
Figure 1. Design of microchannels

Effect of channel geometry on frost damage in microchips. The microchannels were filled with tap water and frozen. Photo 6 shows microchannels of 500 μm in depth after freezing. In the photo, each channel is separated but their dimensions are the same as those in figure 1. Regardless of the freezing pattern, the straight channel was not damaged and the other ink bottle channels were cracked or punched. The channels with smaller cavities suffered small cracks in the first freezing; however, punching occurred at the subsequent freezings. Photo 6 shows the results in which the temperature was decreased gradually for 12 hours. Here, the microchannels of 250 μm in depth suffered only small cracks (Photo 7) after first freezing. However, during the third freezing punching fracture was observed. The straight channels suffered no damage even after ten cycles of freezing and thawing.

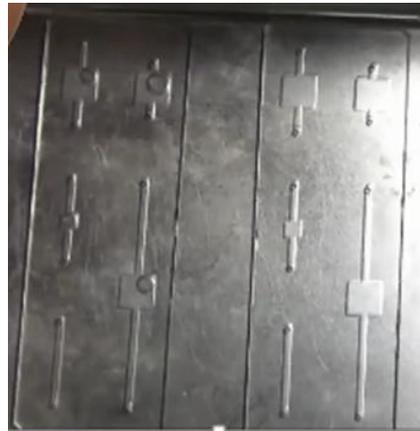
Air bubbles in channels. Air remained in some channels after water permeation. To study the effect of remaining air on frost damage, two types of chips, with and without air, were prepared and frozen (Photo 2). Air was introduced to the channel using a micropipette. Because the air volume was difficult to control, the ratio of air to cavity areas (observed from the top) ranged from 10% to 22%. The water in the channels was frozen using the same technique previously described.

Photo 2. Channels with and without air (left: with air, right: without air)

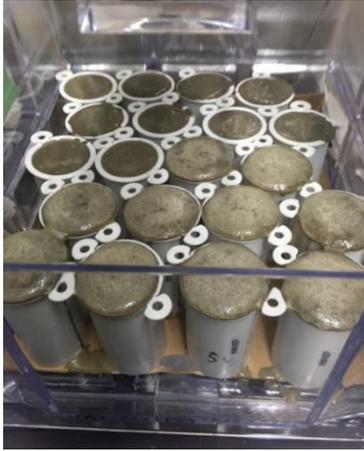
Specimen preparation. Cement paste of W/C = 40% with or without air entraining (AE) water reducing agent (0.5%/cement weight) was prepared with ordinary Portland cement (density = 3.15 g/cm³). The cement paste was placed in plastic cylindrical molds (φ50 × 100 mm) and cured under atmospheric pressure (20 °C, 0.10 MPa) or vacuum (20 °C, 0.02 MPa) for 24 hours. Vacuum curing was achieved using a desiccator of reduced pressure acquired via vacuum pump. The specimens were named A0, A0.5, V0 and V0.5. A and V stand for atmospheric pressure and vacuum, respectively, and the numbers indicate the amount of AE water reducing agent. As seen in Photo 3, V0 specimens, located at the front, expanded and overflowed the molds. Vacuum curing was expected to reduce frost damage on the cement paste since the study of microchannel geometry indicated that channels with a larger ratio of cavity to neck volume reduced frost damage. Vacuum curing was expected to achieve this effect because air bubbles increase in size under vacuuming, by a factor proportional to the initial air bubble size raised to the power of 3/2 [Kijito et al. 2009]. The specimens were demolded and immersed in water (20 °C, atmospheric pressure) 24 hours after casting. After 7 days of aging, the specimens were moved to a desiccator (20 °C, RH 60%). After four days, the specimens were immersed in water for three days. Freezing and thawing test was executed on the 14th day after casting.

Photo. 3. Cement paste under vacuum

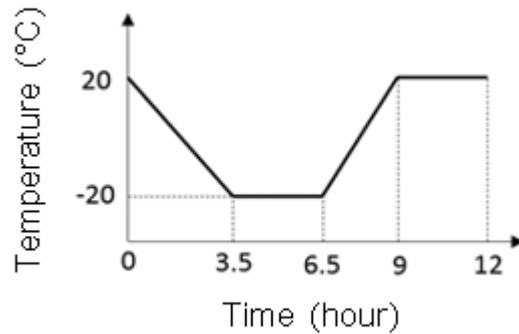
accomplished using a low-temperature liquid tank. Specimens were placed horizontally on a floating tray in antifreeze solution. Water was poured into the tray until the distance between the tops of the specimens and the water surface reached 3 mm. To prevent the tray from overturning, glass slides were placed on the tray to prevent the specimens from rolling. A 12 hour cycle in which the temperature went from 20 °C to -20 °C and back to 20 °C (figure 2) was performed 100 times. The frost damage on the samples was evaluated by mass reduction.

Figure 2. Temperature pattern in freezing and thawing test

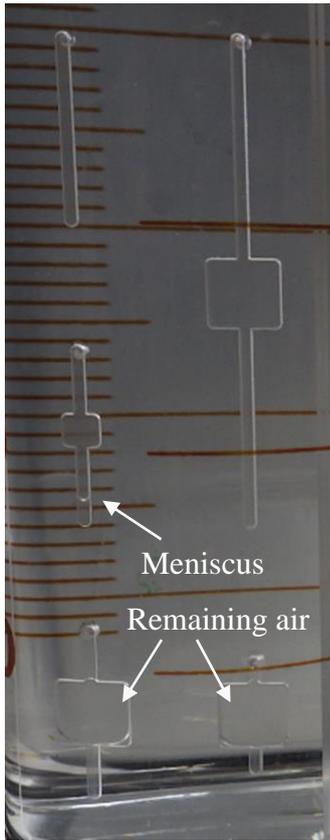
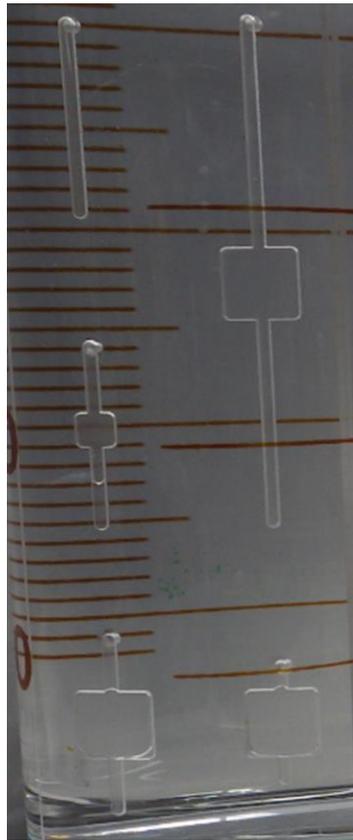
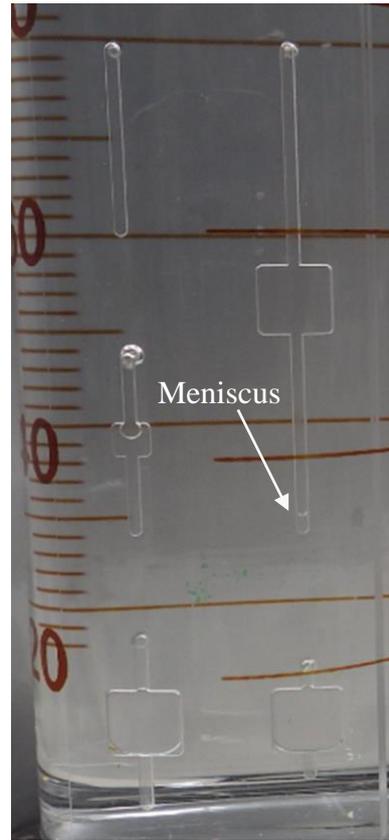
Water permeation into microchannels. The channels with both an inlet and an outlet filled with water immediately after the inlet were submerged in water. Conversely, it took several minutes to several hours (varied depending on the channel type) for the microchannels without an outlet to form a meniscus at their dead end. The channels filled from their dead ends (bottom of Photo 4), as opposed to their inlets. Meniscus formation tended to take more time in longer channel geometries. The air in the channels was pushed out (Photo 5) as the water filled them. The air was removed completely from some channels but remained in the cavities of channels having larger ratios of cavity to neck volume. For these channel geometries, remaining air occupied a large portion of the cavity (Photo 4). The size of the air bubble in the cavity was consistent over the course of one week. No visible air remained in the straight channels.

Photo 4. Water permeation into microchannels after varying elapsed times of immersion

Water permeation into microchannels. The microchannels with both an inlet and an outlet filled immediately with water after the inlet was immersed. Conversely, the microchannels with only an inlet took a long time to fill (Photo 4). This delay is likely due to resistance from the air in the channels. These channels filled from their dead ends, a phenomenon explained by corner flow and film flow in which fluid travels to corners and surfaces of channels first [Harris et al. 1995]. The fluid reached the dead ends, where a meniscus then formed. Applying this concept to water permeation of concrete, it can be assumed that when a hardened concrete specimen is immersed in water, water permeates from all surfaces. This condition corresponds to that of microchannels without an outlet. When hardened cement paste specimens were immersed in water, it was observed that air was pushed from the specimens (Photo 10) as seen with the microchannels (Photo 5). In the study with microchannels, more air remained in the channels having larger ratios of cavity to neck volume. Air remained when a meniscus formed at the neck near the inlet before the cavity could fill with water (Photo 4). Such an air trapping mechanism suggests that the larger the cavity, or the smaller the neck of the ink bottle profile, the more air will become trapped in the channel. Even a straight channel retains large amounts of air, particularly as the permeation length increases [Han et al., 2006].

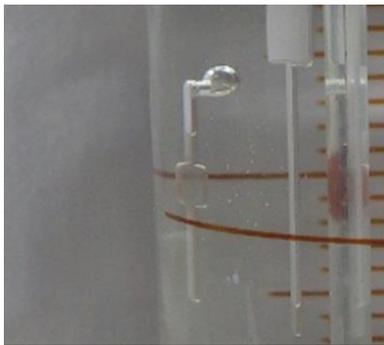
Photo 5. Air pushed out of channel

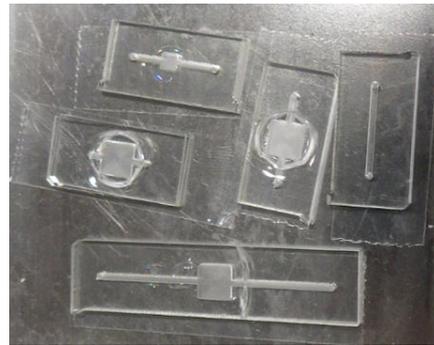
Photo 6. Damaged channels after freezing

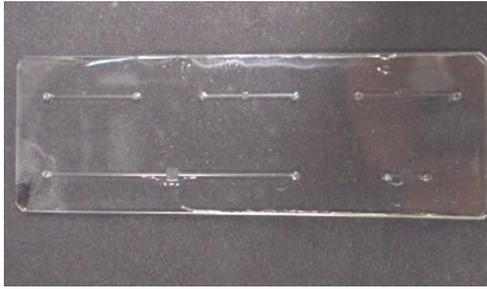
Photo 7. Damage in smaller channels

Ultimately, the freezing of the water remaining in the cavity is what caused the damage, as evidenced by the punching fractures centered within the cavities (Photo 8). More freezing and thawing cycles were required to damage smaller channels because the smaller channels (Photo 7) had less water volume, and therefore less expansion due to freezing, in addition to having thicker slide walls since less glass was removed during machining. Dense concrete with low W/C typically has high damage resistance under standard freezing and thawing testing [Hama et al. 2003], likely due to a similar mechanism as that of the small microchannels.

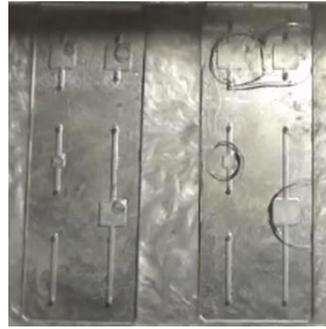
Effect of remaining air on frost damage of microchips. The microchips with and without remaining air bubbles were frozen. Water-saturated channels suffered punching upon freezing but channels with air did not, even after ten cycles of freezing and thawing (Photo 8). Photo 9 shows the magnified air bubble before and after the water was frozen.

Photo 8. Effect of air on frost damage

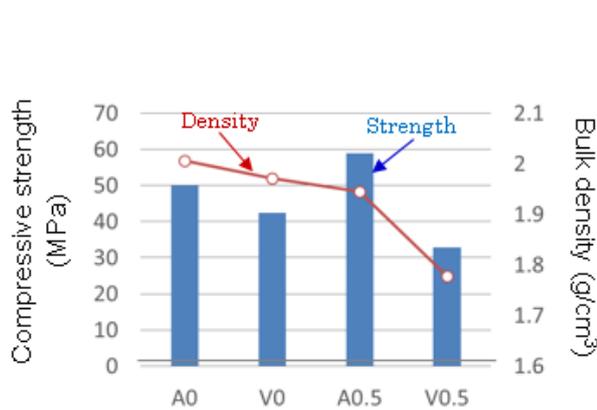
Compressive strength and bulk density. Compressive strength and bulk density are shown in figure 3. Vacuum curing reduced both compressive strength and bulk density in V0 and V0.5 specimens when compared with their A0 and A0.5 counterparts. AE water reducing agent reduced bulk density and increased compressive strength for specimens cured under atmospheric pressure (A0 and A0.5).

Figure 3. Compressive strength and bulk density

Bulk density, compressive strength, and porosity. Vacuum curing reduced both compressive strength and bulk density of the hardened cement paste specimen (figure 3), likely due to the air volume increase associated with vacuum curing. Figure 4 shows that V0 had lower porosity than A0. It is probable that V0 had more pores larger than 10 μm , which is outside of the measurement range of MIP. Vacuum curing increased porosity for pores with diameters of 100-200 nm. Such changes in porosity indicate that the vacuum curing affects not only larger volumes of air such as entrapped and entrained air, but also smaller volumes of air on the nano scale. The fact that V0 and A0.5 had similar porosity curves for pores with diameters exceeding 20 nm demonstrates the similar effect of the AE water reducing agent and vacuum curing on pore structure.

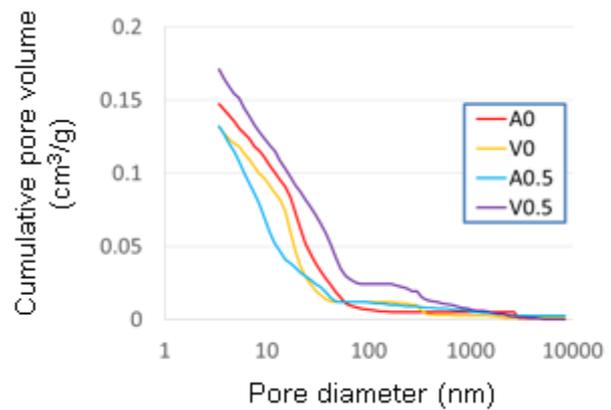
Porosity. Porosity measured with MIP is shown in figure 4. Specimens that were vacuum cured or had AE water reducing agent (V0, V0.5, A0.5) showed increased porosity compared with A0 for pores with diameters of 100-200 nm. Vacuum cured specimen V0 showed reduced porosity for pores with diameters of 30-40 nm compared to A0. Specimens V0 and A0.5 demonstrated similar porosity curves for pores larger than 20 nm in diameter. A0.5 and V0 had lower total porosity than A0.

Figure 4. Pore size distribution

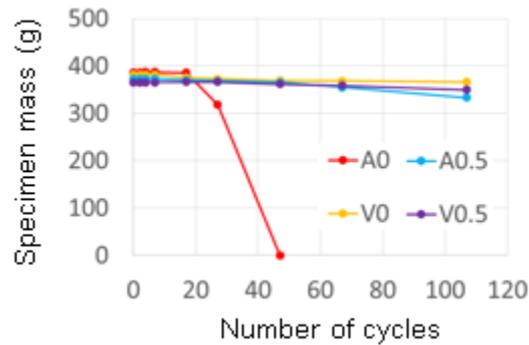
Freezing and thawing test. Figure 5 shows the mass change induced by frost damage. Over 100 cycles of freezing and thawing, A0 collapsed completely and V0 suffered the least amount of damage (Photo 10). The specimens with AE water reducing agent (A0.5, V0.5) did not collapse, but showed surface deterioration. A few large fragments fell off of specimen A0.5.

Figure 5. Mass change during freezing thawing test

Freezing and thawing test. Under atmospheric pressure, the specimen without AE water reducing agent (A0) collapsed at the 50th cycle. On the other hand, all other specimens remained intact through 100 cycles (figure 5) apart from surface deterioration of specimens A0.5 and V0.5 (Photo 10). The specimen cured under vacuum condition without AE water reducing agent (V0) avoided even surface damage. The above results indicate that vacuum curing is effective in improving resistance against frost damage, including surface deterioration, although it can reduce compressive strength and bulk density (figure 3). If vacuum curing enlarges the cavities of ink bottle geometries in cement paste specimens, and air remains entrapped, then the effect of the remaining air is improved resistance to frost damage as seen with the

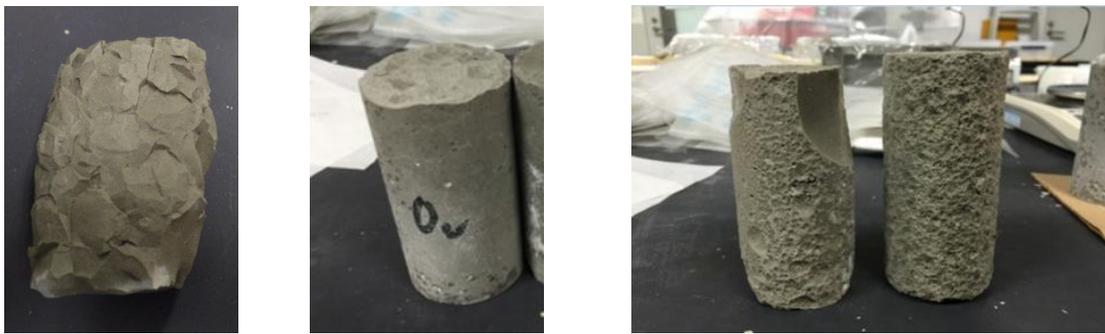
Photo 10. Specimens after freezing and thawing test (left to right: A0, V0, A0.5, and V0.5)

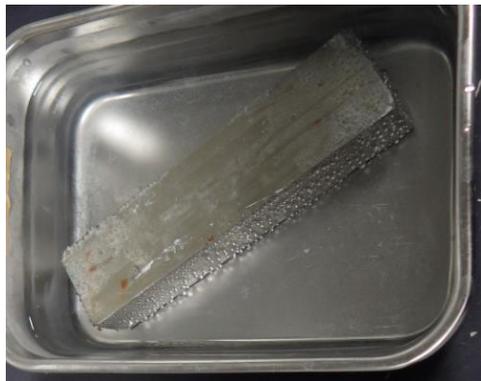
Photo 11. Air pushed out from hardened cement paste
