SCMT4
Las Vegas, USA, August 7-11, 2016

Sustainable Renewal Plan for RC Slab of Expressway Steel Girder Bridges in Japan

¹*Engineering/Construction Headquarters, Central Nippon Expressway Co. Ltd., JAPAN.*

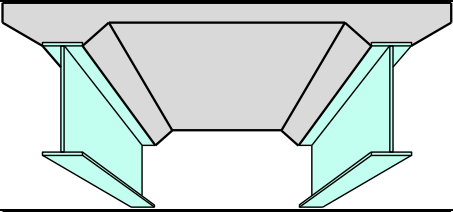
| Stage | Development and mechanisms of deterioration | Deterioration progress figure |
|---|---|--|
| 1 | <p>➤ Initial service stage No harmful cracks are found at the initial service stage.</p> | |

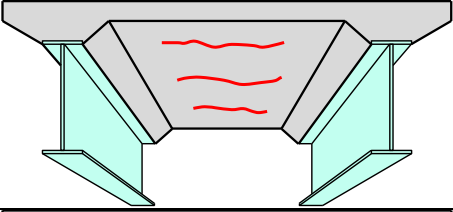
| Stage | Development and mechanisms of deterioration | Deterioration progress figure |
|---|---|--|
| 2 | <p>➤ Unidirectional cracks occur Cracks on the floor slab occur in one direction due to drying shrinkage, etc. Because the shrinking slab is restrained by steel girders, etc., cracks perpendicular to the bridge axis develop easily.</p> | |

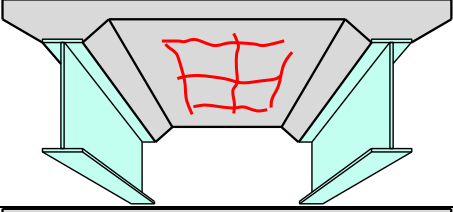
| Stage | Development and mechanisms of deterioration | Deterioration progress figure |
|---|---|--|
| 3 | <p>➤ Grid-like pattern cracks propagate Lengthwise and crosswise cracks occur alternately and cracks in a grid-like pattern increase. Lengthwise and crosswise cracks gradually advance due to the effects of live load, accompanied by the gradual degrading of shear stiffness and torsional shear stiffness.</p> | |

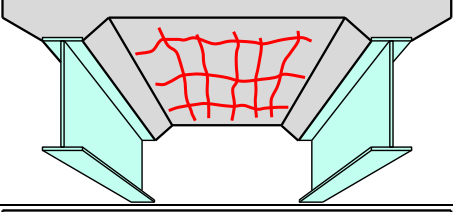
| Stage | Development and mechanisms of deterioration | Deterioration progress figure |
|---|---|--|
| 4 | <p>➤ Cracks penetrate to the top surface While the bidirectional cracks propagate, new cracks further propagate until they form a grid-like pattern. Moreover, flexural cracks penetrate through the floor slab due to cyclic traffic loading.</p> | |

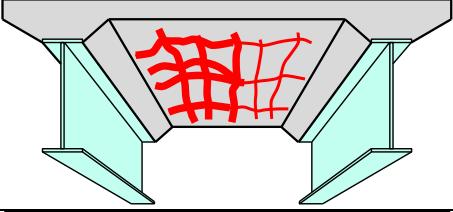
| Stage | Development and mechanisms of deterioration | Deterioration progress figure |
|---|---|--|
| 5 | <p>➤ Degradation of shear resistance on the crack fracture Shear resistance degrades as the abrasion phenomenon occurs on the crack fracture surface. Particularly significant when water is present. Rainwater penetrating into the through cracks causes efflorescence to form deposits on the bottom surface of the floor slab. Leaching rust from rebars adheres to the surface as well.</p> | |

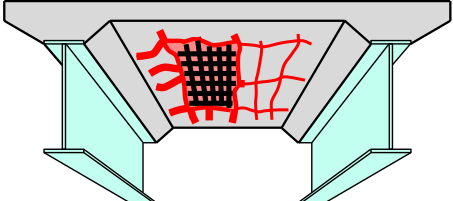
| Stage | Development and mechanisms of deterioration | Deterioration progress figure |
|---|---|--|
| 6 | <p>➤ Concrete spalling occurs Although the increase of crack density stops when the bidirectional cracks develop to about 20 to 30 cm squares, punching shear strength degrades significantly such that wheel loads exceeding this strength cause concrete to spall.</p> | |

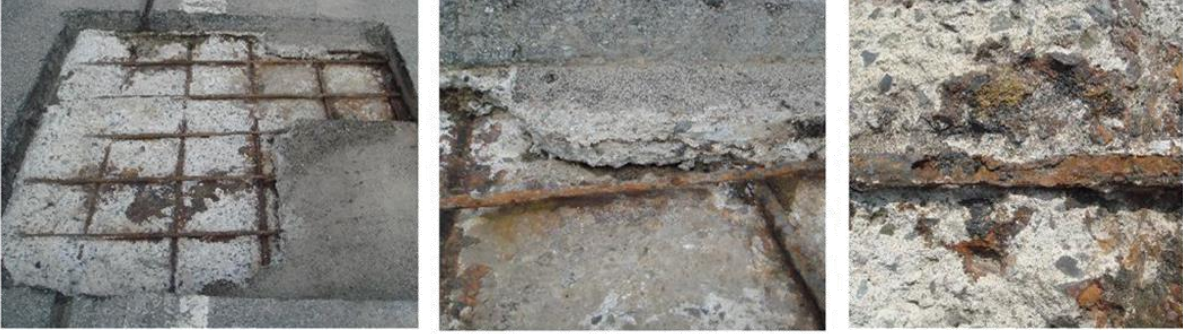
Photo 1. Corrosion of Rebar and Spalling of Concrete on the Upper Surface of Floor Slab

Inspections of existing bridges revealed that the main factors causing deterioration of the RC floor slabs of steel girder bridges are fatigue from vehicle traffic through the bridge and salt damage due to antifreezing agents and airborne salt. The stages of development and mechanisms of deterioration caused by floor slab fatigue are shown in Table 3. Degradation due to salt damage from antifreezing agents are shown in Photos 1 and 2

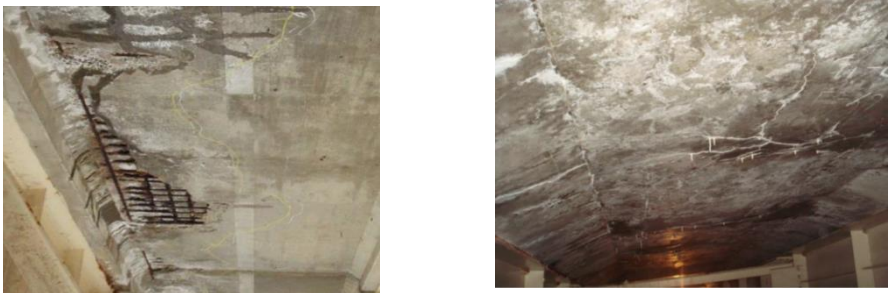
Photo 2. Corrosion of Rebar and Spalling of Concrete on the Lower Surface of Floor Slab

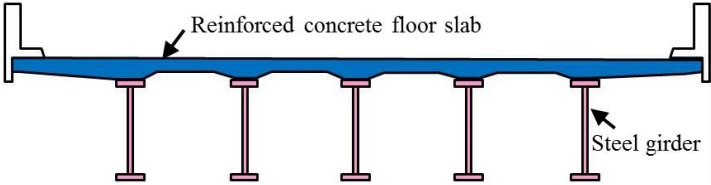
Figure 1. Cross Section of Steel Girder Bridge with RC Floor Slab

The renewal plan for RC floor slab of steel girder bridges is a program to replace current RC floor slabs, depicted in Figure 1, with new ones when abnormalities in the floor slab due to fatigue, salt damage and other factors have advanced to a stage where its structural performance falls below the required performance for expressway bridge slabs.

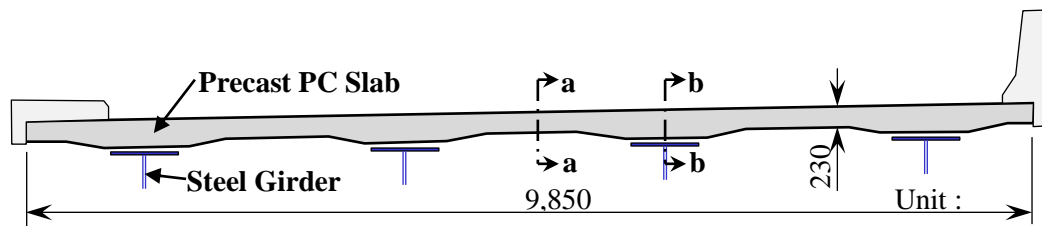
Figure 2. Cross Section of Precast PC slab

The precast PC slab for use in the renewal will be fabricated at the shop or onsite yard with prestressing forces introduced through a pre-tensioning system and will be transported to the bridge site by trailer trucks or similar means for erection. The slab will normally be segmented into a width (of about 2 - 2.5 m in general) in the longitudinal direction of the bridge that is transportable by trailer trucks or similar means. Further segmentation in the bridge transverse direction may also be done when the bridge roadway is wide or when road traffic control during construction calls for it. In general, joints between slabs will be built in-situ as RC structures using loop rebar joint. An example cross section of the precast PC slab and joints between slabs using loop rebar joint is shown in Figure 2, 3 and 4. And an example construction of the precast PC slab is shown in Photo 3 and 4.

There is negative moment at the support regions of the new slab, as Fig. 2. In the design, the new slab is not allowed the occurrence of cracks in the serviceability limit state. Therefore, it is possible to prevent corrosion due to generation of cracks, and the slab upper surface is covered waterproofing as a multi-layer protection. In addition, the deterioration does not have been confirmed after 15 years in the same type of slabs. In the inspection for maintenance, it is necessary to check for deterioration of occurrence of the pavement surface because it is difficult to visually occurrence of cracks on the surface of slab.

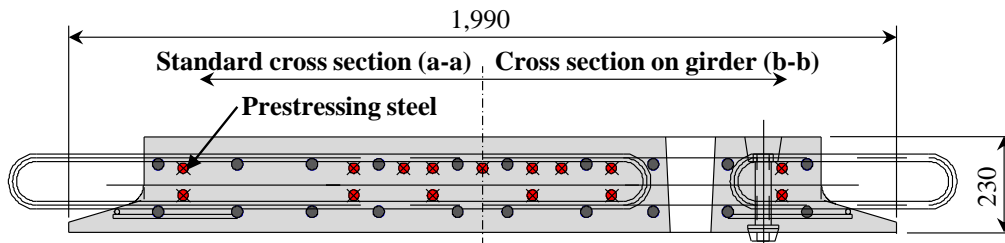
Figure 3. Cross Section of Precast PC slab Segment

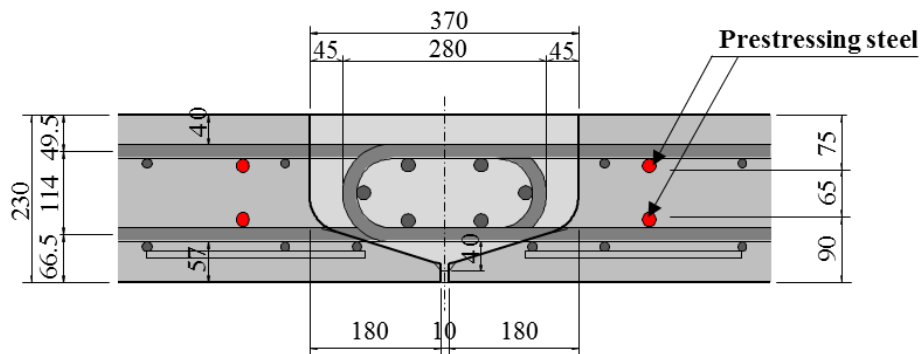
Figure 4. Cross Section of Joints between Slabs using Loop Rebar Joint
