SCMT4
Las Vegas, USA, August 7-11, 2016

External CFRP Reinforcement Impact on RC Wall Behavior, Subjected to Quasi-Static Cyclic Load Test

Samiullah QAZI¹, Laurent MICHEL^{2a} and Emmanuel FERRIER^{2b}

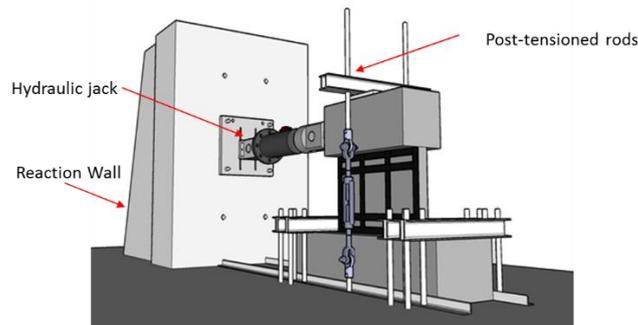
Figure 1. Test setup

To simulate seismic loading the test specimens were subjected to displacement control lateral cyclic loading under a constant axial load, with the walls acting as cantilevers (Figure 1). The axial load ratio (ratio of the applied axial load to the axial load capacity) at the concrete section has a significant influence

on the shear wall's performance, deformability and failure modes [Lefas et al. 1990; Oh et al. 2002; Su and Wong 2007; Lestuzzi and Bachmann 2007]. In this case a constant axial compression load of 110 kN was sustained at head beam. To simulate seismic actions specimens were subjected to reverse static cyclic load test. According to recommendation of ACI [ACI T1.101, 2001], specimens were subjected to three full cycles at each level. Due to variation made in external CFRP reinforcement configurations of all specimens, the lateral displacement load levels were based on drift instead of ductility for ease in performance comparison. Since deformation based methods promise more realistic results than the force based methods, the former should be applied on existing buildings too [Priestley 1997]. The applied lateral displacement load levels were maintained at drift levels of 0.1%, 0.2%... 0.8%, 1%... 1.8%. with a speed of 10, 20... 80,100,120 .180 mm/min, respectively.

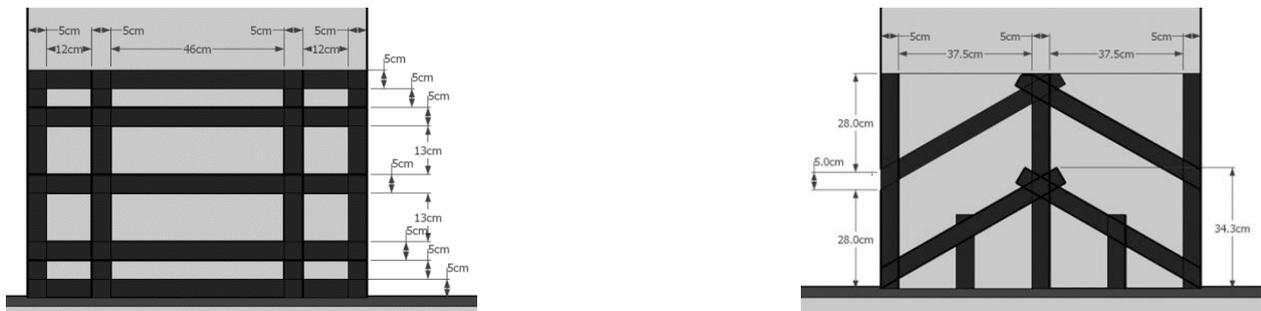
Figure 2. CFRP reinforcement schematic detail (Wall SR4 and SR6)

Retrofitted specimens SR4 & SR6. The choice of a reinforcement pattern is always difficult due to some antagonistic parameters (e.g., maximum load and energy dissipation). The adopted external CFRP reinforcement pattern was based on the crack pattern observed in the RC wall load test. Two pattern were used in first case (SR4) the CFRP strips were bonded parallel to wall steel reinforcement while in second (SR6) the CFRP strips were bonded in direction orthogonal to diagonal cracks to bridge the cracks more efficiently (Figure 2). The composite reinforcement was made from carbon fabric bands that were 50 mm wide and 0.48 mm thick. The Young's modulus is 105 GPa, and the ultimate strength is 1400 MPa. The concrete surfaces were mechanically sanded to achieve a good quality bond between the concrete and the CFRP.

The two faces of the wall were made smooth by sandblasting before strengthen them with CFRP. The CFRP strengthening configuration applied in shown in figure. To limit CFRP strip debonding in vicinity of wall foundation joint and efficient transfer of load from CFRP to foundation block, all the vertical bands were connected to the lower foundation through anchor strand composites. This extra reinforcement confirmed better use of the mechanical properties of carbon bands. The employed mesh anchor had an

overall length of 40 cm and consisted of 26 fiber tows. Each anchor was embedded in drilled hole made in foundation block up to a length of 150 mm (5.90 in.) and its remaining length was splayed over the vertically bonded FRP strips. This was then over-bonded by a CFRP strip splayed in direction perpendicular to wall vertical axis. In specimen SR6, to limit CFRP strips debonding with in wall panel, mesh anchors were placed in holes, which were drilled within the wall panel at CFRP strips intersection point.

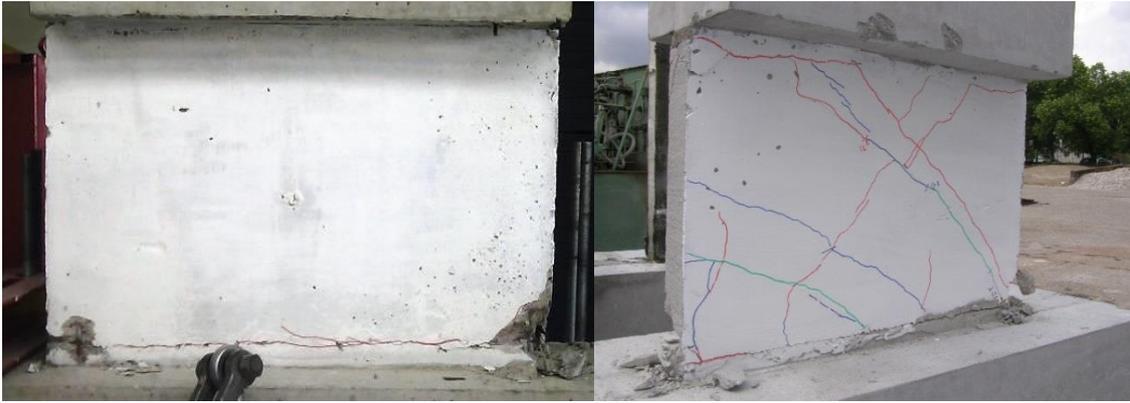
Figure 3. Specimen S3 Failure pattern

Failure modes. Figure 3 shows a picture of the failed specimen S3. At test end a flat crack developed along the construction joint, which covered the entire wall length. This was accompanied with concrete crushing and lap splice rebar buckling at wall toe, at both ends.

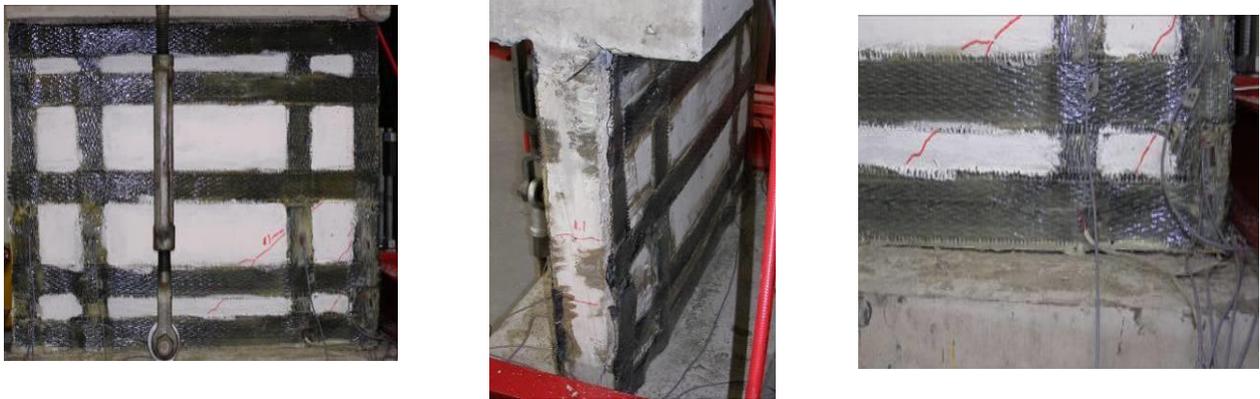
Figure 4. Specimen SR4 Failure pattern

Figure 4 show photos of failed specimen SLR4. In this case diagonal cracks developed at wall free end. Initially a crack developed in the wall, at one fourth of its height, at induced displacement of 6.48 mm and load of 170.5 kN. Another crack developed diagonally at the wall mid height at induced displacement of 8.1 mm and load of 150 kN. Both cracks spread towards the wall foundation joint and were not superficial as they developed at both wall faces including wall end. The cracks formed at wall free end because the test was initiated with pushing therefore at each load level the wall free end first experienced compression and then tension. This initial compression initiated CFRP debonding and buckling at free end as it cannot withstand compression load. This in turn resulted in tensile cracks initiation at the wall free end during pulling as the RC section could not sustained higher tensile stresses. The CFRP debonding is shown in second photo (Figure 4). The test was stopped at displacement load level of 9.72 mm due to formation of flat crack at the wall foundation joint and reduction in sustained load up to 30 %. The flat crack at wall foundation joint originated at wall free end and surpassed at half length of the wall. At the final stage of test, toe crushing and rebar yield at the wall free end was observed.

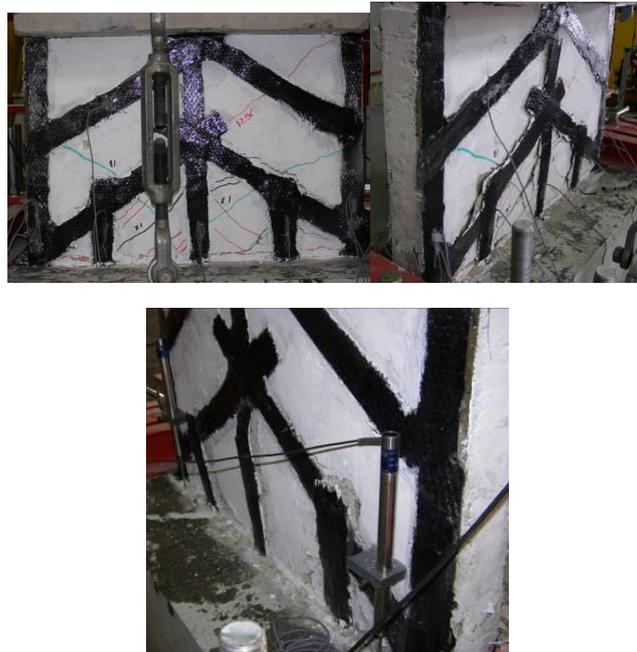
Figure 5. Specimen SR6 Failure pattern

Though specimen SR6 showed an overall improvement in ductility and strength as compared to SR5, yet the wall panel crack pattern was almost identical in the two. Figure 5 depicts specimen SR6 failure pattern. At induced load level of 8.1 mm two diagonal cracks, one at each end appeared at the wall panel lower half. These cracks propagated across the diagonally bonded CFRP strip and touched the wall bottom in vicinity of its mid-length. However the diagonally bonded strips reduced the crack widening to a certain extent. Afterwards a number of diagonal cracks developed within wall panel lower half middle portion accompanied with another diagonal crack along wall free end upper diagonal while touching the CFRP strip bonded in the same direction. At test end, debonding was observed in the CFRP strips located within the wall lower half. It included debonding of strips along the wall diagonals and the interior vertical strips. On the other hand in wall upper half portion, the vertically bonded strip located at wall mid-length, ruptured beneath the intersection point of diagonally bonded CFRP. In this case the CFRP debonding was not severe as in case of SR5 due to the improvement made in the transverse mesh anchors introduced at CFRP strip intersection points.

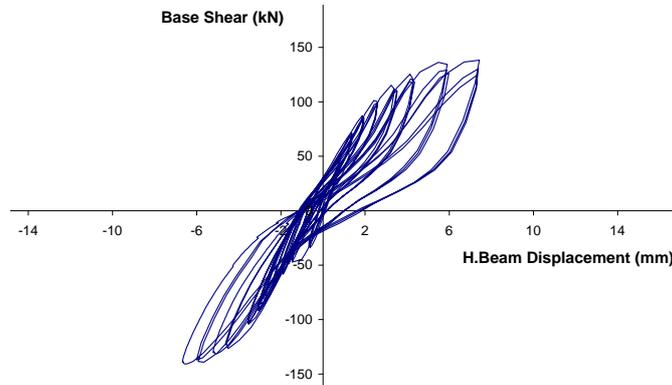
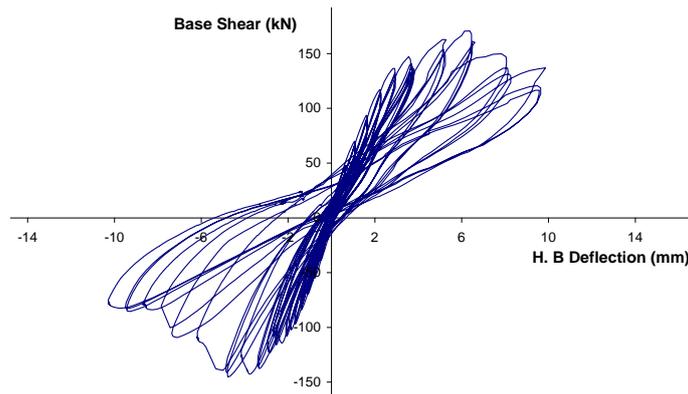
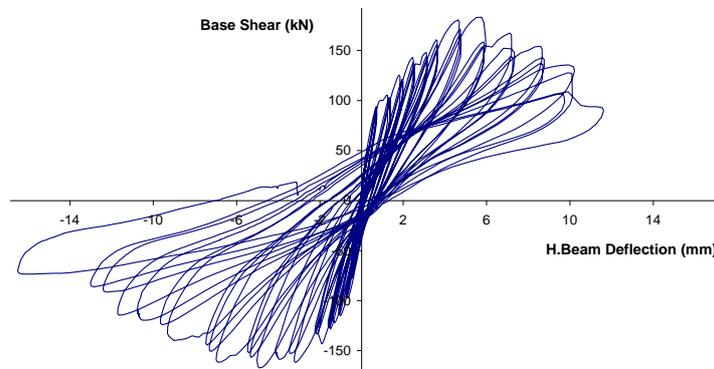
Figure 6. Hysteresis curve

Hysteresis Curve. The hysteresis curves (Figure 6) depict the variation in the cyclic load response behavior of all the specimens (S3, SR4 & SR6). The observed max load sustained by S3, SR4 and SR6 is 138.69, 170.53 and 169.44 kN respectively. The hysteresis curves indicate an increase in the initial stiffness in specimens SR4 and SR6 as compared to S3. The relatively higher initial stiffness of SR6 in comparison to SR4 is owed to the additional transverse mesh anchor arrangement made within the wall panel. The pinching of hysteresis curve of specimen

SR4 and SR6 as compare to S3 at identical load level, after the crack initiation, point out that the additional CFRP external reinforcement depreciate the dissipation capacity of the RC wall. The comparative analysis of SR4 and SR6 indicates a relatively smooth decline in the sustained load of SR6 after exceeding their ultimate capacity. This difference in behaviors is owed to transverse mesh anchor which retained the CFRP intact with concrete surface and thus avoided abrupt failure on a large scale.

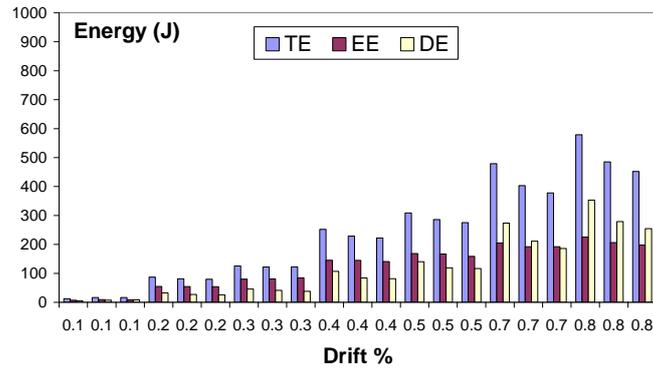
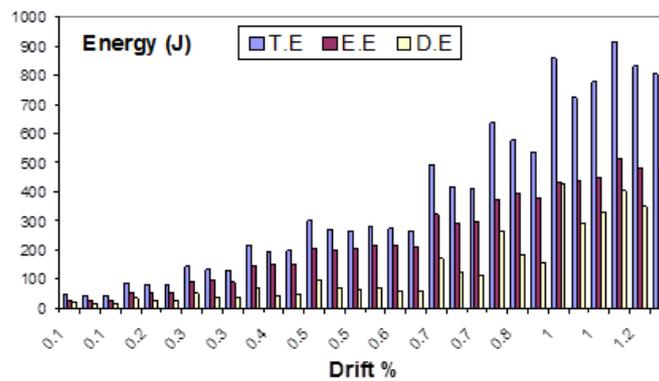
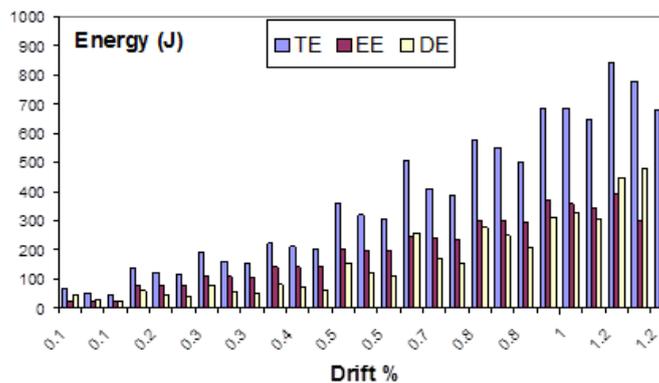
Figure 7. S3, SR4 and SR5 T.E, E.E and D.E bar charts

Elastic and dissipated energy. For test specimens S3, SR4 and SR6 the total, elastic and dissipated energy values are given in Figure 7 in the form of bar charts. The energy values correspond to half load cycles and were evaluated by use of trapezoidal rule. The total, elastic and dissipated energy were evaluated by computing the area under the loading curve, under the un-loading curve and in between the loading and unloading curves, respectively. In all the three specimens the dissipated energy at each load level decreased with relative increase in cycle number, due to smoothening of the cracked surfaces. Specimens S3 and SR6 at their ultimate drift level (0.8 and 1.2%, respectively) exhibited higher amount of energy dissipation in comparison to their elastic energy (E.E).
