SCMT4
Las Vegas, USA, August 7-11, 2016

Residual Mechanical Properties of Fire Exposed GFRP Reinforcement in Concrete Elements

*O. Gooranorimi^{1a}, G. Claire^{1b}, F. De Caso^{1c}, W. Suaris^{1d}, A. Nanni^{1e}

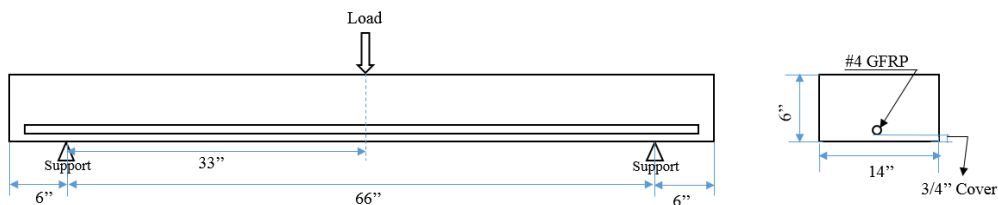
Figure 1. Schematic of GFRP-RC Slab (Note: 1 in=25.4 mm)

Gravity {Relative Density} of Plastics by Displacement), [Claire, et al., 2015]. GFRP-RC slabs were designed with a single GFRP bar located at the center with 19 mm (0.75 in.) of clear concrete cover, corresponding to minimum cover per design requirements. All structural elements were monolithically cast from a single batch, with normal weight concrete consisting of type I cement, with a maximum aggregate size of 6.4 mm (0.25 in.), and an average 28-day compressive concrete strength of 42.3 MPa (6135 psi) according to ASTM C39 (Standard Test Method for Compressive Strength of Cylindrical Concrete Specimens). Figure 1 illustrates the slab geometry, load configuration used for both fire test and post-fire static test at ambient conditions, and the location of the GFRP reinforcement. The theoretical design capacity of the GFRP-RC slabs was according to ACI 440.1R (Guide for the Design and Construction of Structural Concrete Reinforced with FRP bars) with a strength reduction factor ($\phi = 0.55$) for tension-controlled limit state and environmental reduction factor of ($C_E = 0.8$). The slabs were designed so that failure was controlled by rupture of the GFRP bars (under reinforced). Internal type-K thermocouples were installed at mid-span to measure the maximum temperature of the reinforcement and concrete during the test.

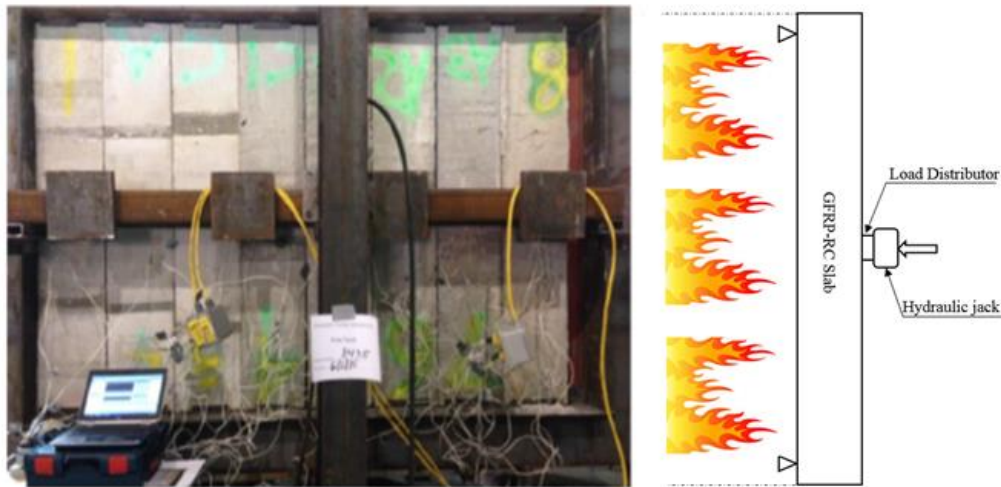
Figure 2. GFRP-RC Slabs during the Furnace Fire Test

Furnace Fire Exposure Test. RC slabs were placed side by side vertically at the furnace opening, with the flexural side of the slabs facing the furnace, held on a steel frame providing simple support conditions and tested simultaneously for two hours per ASTM E119. A rigid deep steel spreader beam was used to equally distribute the load from a hydraulic jack to each slab independently, resulting in service point load (P_{ser}) at mid-span equivalent to 5.78 kN (1300 lbs) per slab, applied simultaneous during the furnace fire exposure. Load cells and pressure gauges were used to verify and maintain the load during the fire test as illustrated in Figure 2. The gaps between the slabs and the steel frame were filled with flexible fire resistant insulation to ensure that any furnace gas heat and pressure was not lost. The ASTM E119 standard temperature-time curve constructed with a number of discrete points is approximated in equation (1), where T is the temperature in Celsius, t refers to the time (hours), and T_0 corresponds to the ambient temperature ($^{\circ}\text{C}$).

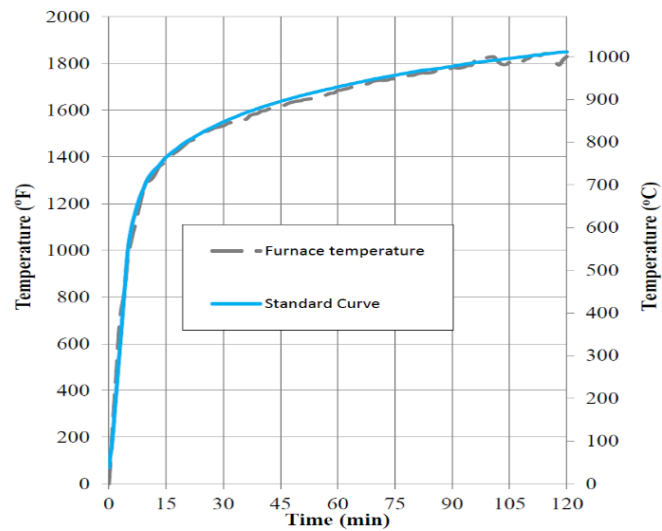
Figure 3. Temperature Profile of the Furnace

The actual furnace temperature-time curve was measured during the test using the average value of the temperature readings from nine shielded furnace thermocouples, distributed evenly inside the furnace. This was matched when compared to the standard curve profile, as seen in Figure 3. The maximum average internal temperature reached by the GFRP reinforcement at 2 hours was 115°C (240°F), which is within the range of T_g temperature of the bars when softening initiates. While it is inferred that at 76 mm (3.0 in.) from the exposed face, the temperature within the concrete was not higher than 75°C (167°F) [Claire, et al., 2015].

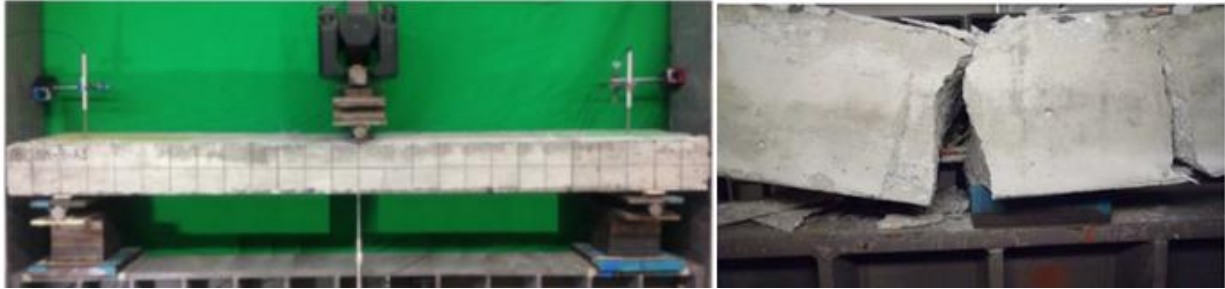
Figure 4. Fire-exposed Slab during Static Test and Failure Mode

Slab Residual Strength. The control and fire-exposed slabs were tested in a three-point bending configuration at ambient temperature, where the fire-exposed slabs were allowed to condition for a period of 7 days prior to the static test. Testing was performed using a hydraulic MTS universal test frame under displacement control until failure. During testing, the applied load, the mid-span deflection, and settlements at the supports were recorded. The load test configuration is presented in Figure 4 where a representative fire-exposed slab is shown during testing and the failure mode [Claire, et al., 2015].

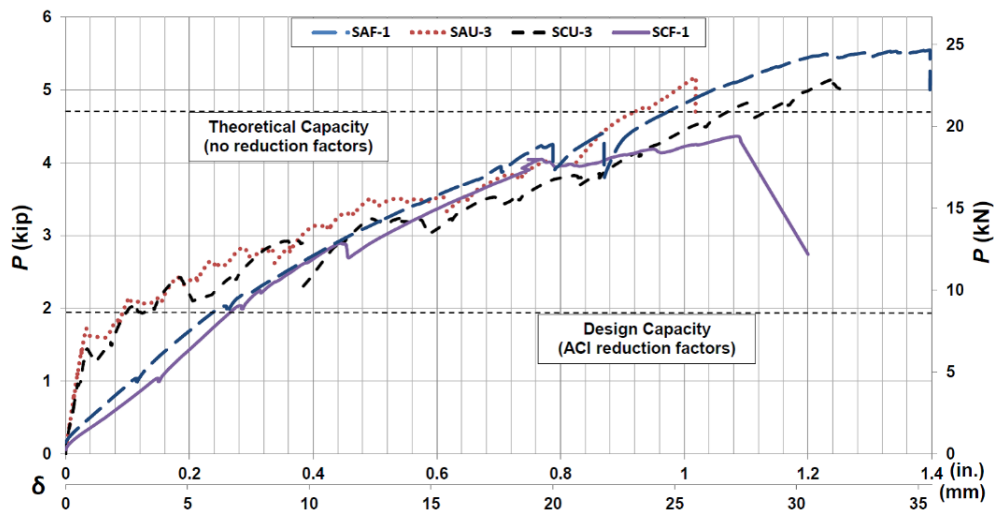
Figure 5. Load vs Mid-span Deflection for Control and Fire Exposed Slabs

Average ultimate load capacity results of control and fire-exposed slabs are summarized in Table 2, including ultimate experimental load (P_{u-exp}), theoretical capacity (P_{th}) which does not include safety factors (ϕ , C_E), and design capacity (P_{Des}), which includes ϕ and C_E , based on ACI 440.1R. The ratios between the experimental results versus the theoretical and design capacities are also provided. Furthermore, the average residual slab strength (RSS) is computed based on the ratio of the average experimental loads (P_{u-exp}) between the fire-exposed slabs to that of the control slabs for each rebar. Overall, based on these results, slabs reinforced with GFRP-A rebar had an increased average peak load of 10%, whereas slabs reinforced with GFRP-C rebars experienced an average decrease of 10%. In any case, the load capacity exceeded the predicted values (P_{th} and P_{Des}). The reduction in capacity of slabs reinforced with GFRP-C may be due to the type of surface enhancement, where softening and deformation of the lugs resulted in the reduction of concrete to GFRP rebar bond. Furthermore, we can determine that the structural behavior of fire-exposed slabs is consistent with the expectations, having a constant stiffness until failure due to the fact that the cracking moment was previously reached during the fire test; while the benchmark slabs do have a change in stiffness after cracking at a range of 6 to 8 kN (1.5 to 1.8 kips), matching the stiffness of the fire-exposed slabs, as seen in the load vs mid-span deflection diagram in Figure 5, for representative slabs.

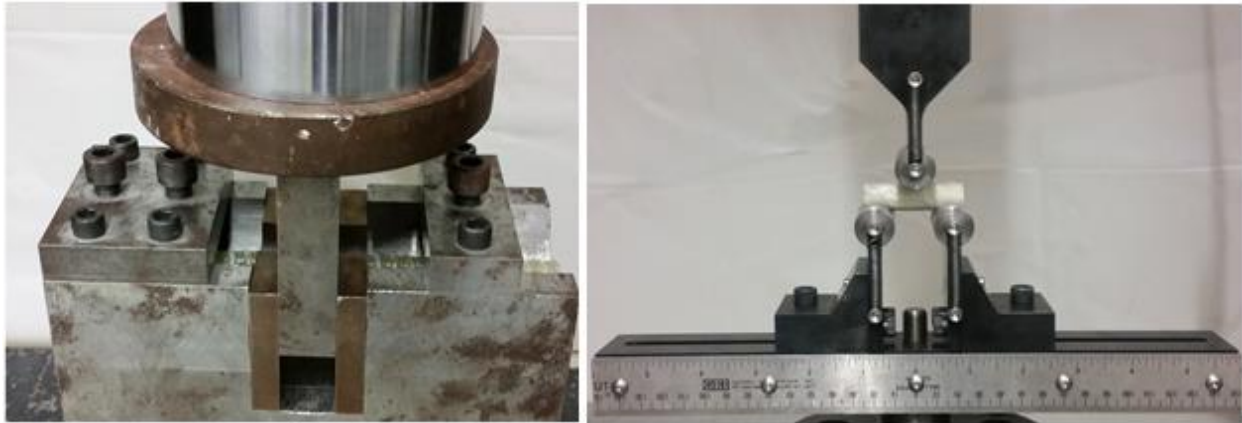
Figure 6. GFRP Bars Tested in Transverse Shear (left) and Short Beam Horizontal Shear (right)

each bar type were tested as shown in Figure 6. Loading was applied at a rate of 1.27 mm/min (0.05 in/mm). Table 4 reports the average results, where τ_P^H refers to the horizontal shear strength of the pristine bar, and τ_F^H refers to the horizontal shear strength of fire exposed samples. Based on the results, after 120-minutes of fire exposure, the interlaminar shear strength of both GFRP rebars have increased 15% and 7% for GFRP-A and GFRP-C, respectively. This outcome provides critical information on the resin performance, which is the primary mechanism for interlaminar shear transfer. It may be reasonable to assume that the furnace fire temperature provided additional curing of the resin, resulting in an increased interlaminar shear strength of the bars. It is also noted, that the difference between both GFRP rebars is of approximately 50%, as previously experienced in the transverse shear results. Currently, no values have been suggested for the minimum requirement of the horizontal interlaminar shear strength of GFRP rebars.

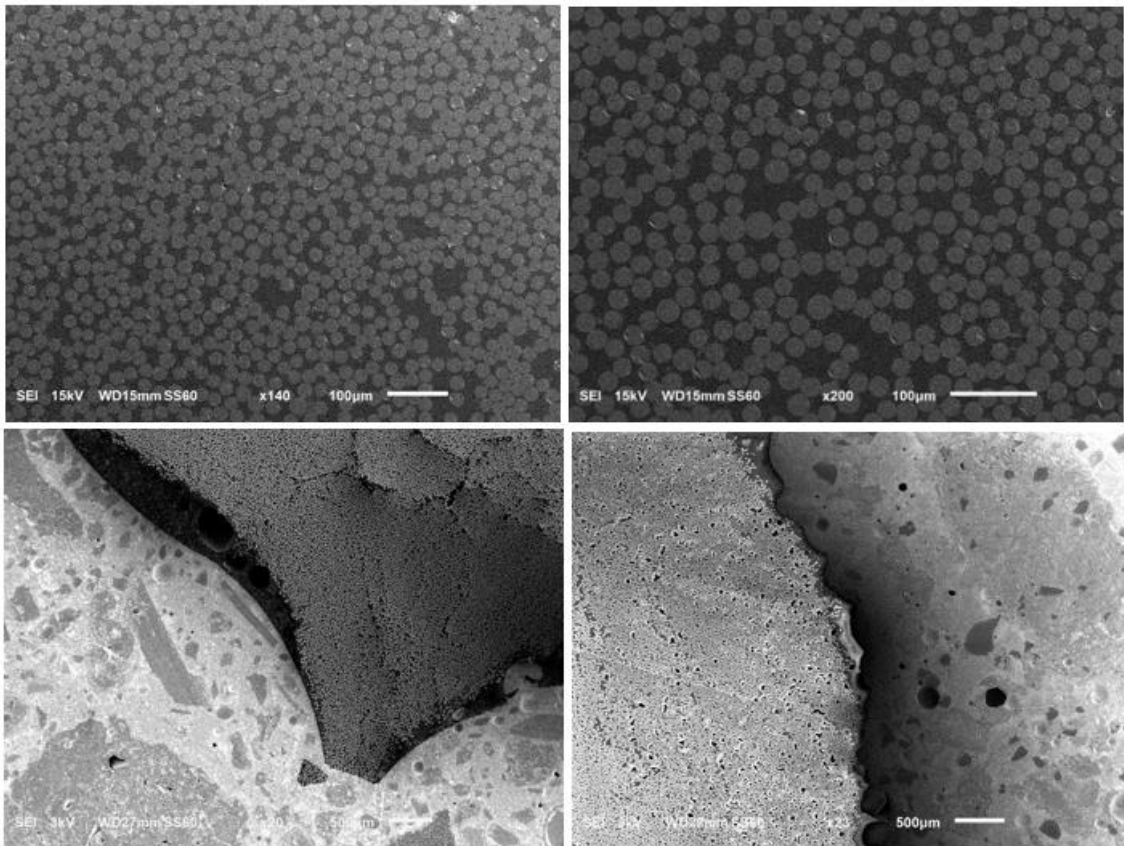
Figure 7. SEM Images of GFRP-C (left-top), GFRP-A (right-top), Concrete-Rebar Interface: GFRP-C (left-bottom) and GFRP-A (right-bottom)

Scanning Electron Microscopy Imaging. Microscopic examination allows to visually detect possible damages at the single fiber scale while capturing physical degradation in the fibers, matrix or concrete-rebar interface. GFRP samples were cut in approximate thickness of 7.0mm (0.27 in.). The rebar specimen surfaces were prepared by sanding using different level grits (level 180, 300, 600 & 1200) and employing dedicated grinding & polishing equipment; a fine polishing completed the specimen preparation using a wet-polishing agent. Prior imaging, specimens were placed in an oven at 60°C (140 °F) for 24 hrs. to remove moisture produced during polishing procedure. Since GFRP bars are non-conductive materials, an ion sputtering device was used to coat the samples with gold prior to SEM examination. After visually analyzing numerous specimens, GFRP samples did not show any microstructure degradation after fire exposure and no damage was observed in the matrix nor resin-fiber interfaces. Since, bond degradation between concrete and reinforcement plays a critical role in fire behavior of the structure, concrete-GFRP interface were also examined, and no apparent damage or degradation was observed. SEM was performed at different magnification levels, where representative images are presented in Figure 7.

- Microscopic examination using SEM imaging did not show microstructural degradation caused by the furnace fire within the GFRP bars or at the interfacial bond in GFRP-concrete interface.
