DURABILITY OF MECHANICAL PROPERTIES OF GFRP REBARS EXPOSED TO SEAWATER

Alvaro Ruiz Empananza¹, Francisco De Caso Y Basalo², Raphael Kampmann³, Pedro Rodrigues de Castro Jalles⁴, Antonio Nanni⁵

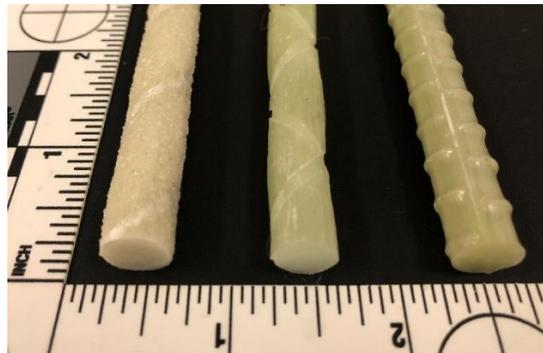
The experimental program consisted of testing three commercially available GFRP rebar types (see Figure 1), before and after exposure to seawater. All tested rebars had a nominal diameter of 10mm and were made from the same fiber (EC-R Glass) and resins type (Vinyl-Ester). However, the manufacturing process varied and they all had different surface enhancements; critical for the bond-to-concrete behavior (Ruiz Empananza et al., 2018).

Figure 1. GFRP rebar types A, B, and C, from left to right

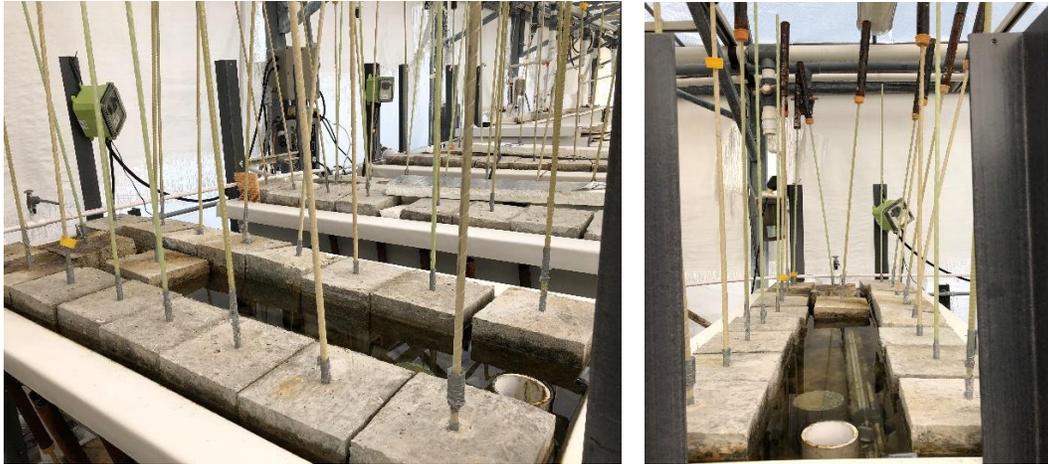
The aging of the rebars was accomplished via accelerated conditioning protocols (ACP), by exposing the rebars to seawater at different temperatures (23, 40 and 60°C) and dissimilar exposure times (60 and 120 days). The rebars were exposed naked in tanks, which circulated seawater directly taken from Key Biscayne (Florida), as seen in Figure 2. The only specimens for which the rebars was not exposed directly to the aging solution were the bond samples: in this case a concrete cube (200 mm long sides) was cast around one of the ends of the rebar, prior to being submerged in seawater.

Figure 2. Exposure of the GFRP rebar samples to seawater

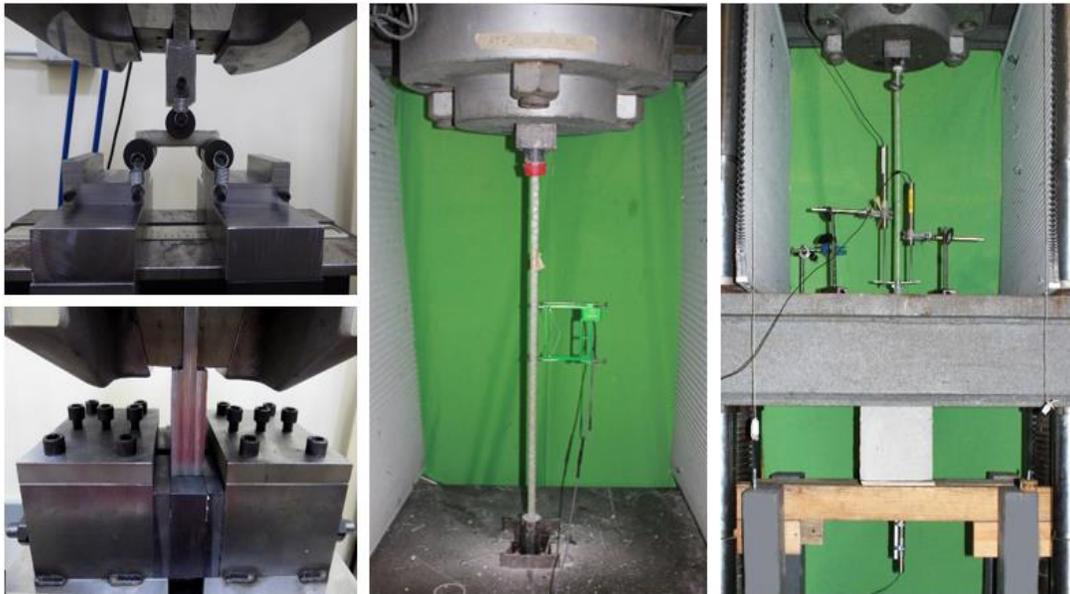
Each rebar property was determined by following the pertinent ASTM standards. All testing was displacement controlled, and the test rates for transverse and horizontal shear, and bond tests were 1.3 mm/min, while the tensile test specimens were tested at a rate of 2 mm/min. As per ASTM, for transverse and horizontal shear tests, the crosshead displacement and the load were recorded. For the tensile tests, in addition to the load, a 100 mm long extensometer was used to record the strain, which was needed to determine the modulus of elasticity. Finally, the instrumentation used for the bond tests included three LVDTs in addition to the load cell: two at the loaded-end and one at the free-end, as specified by ASTM D7913 (ASTM, 2014), to measure both the free-end and loaded-end slippages. Figure 3 shows the test setup of the different tests that were run for this research project.

Figure 3. Horizontal shear test (top left), transverse shear test (bottom left), tensile test (center), and bond test (right)

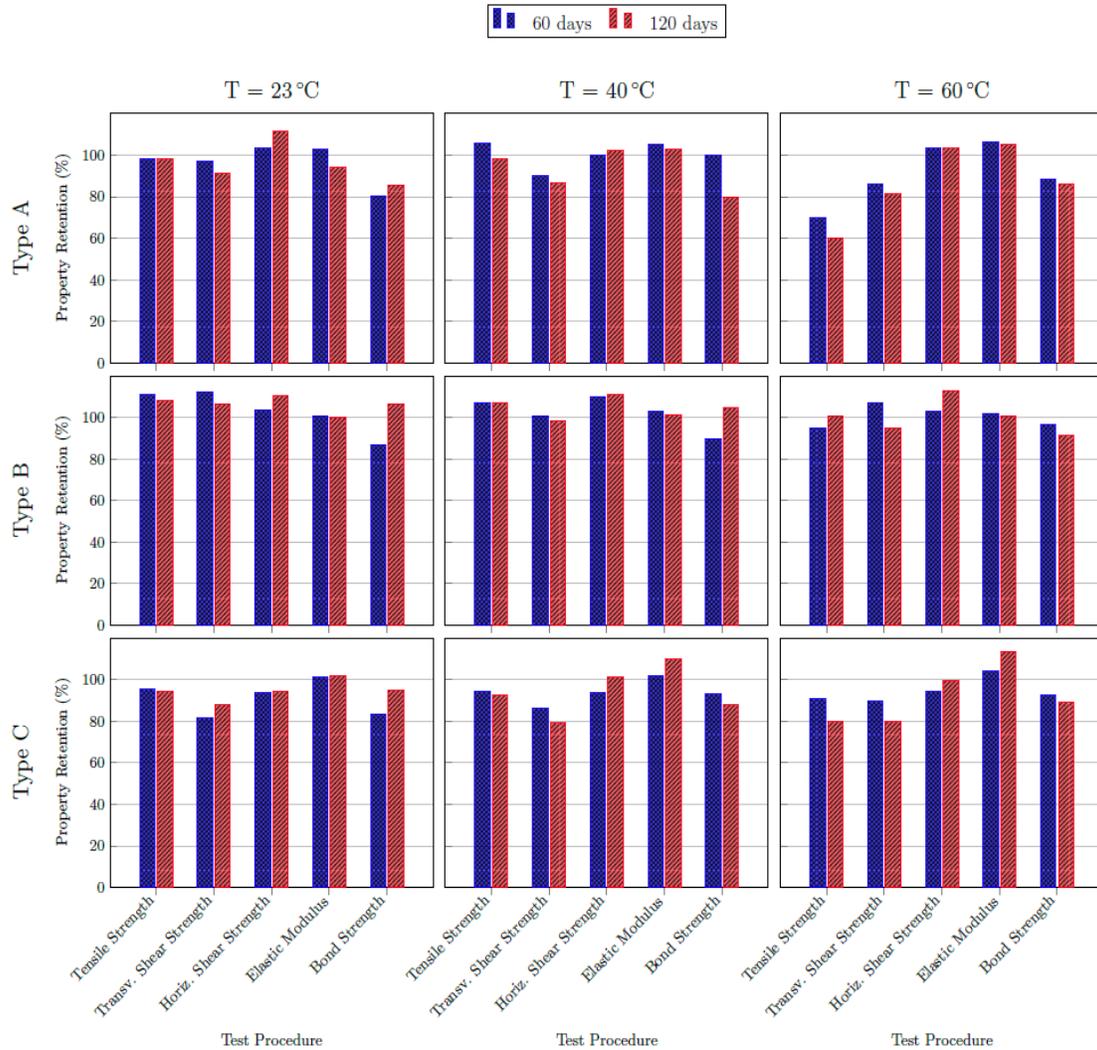
Rebars taken from the same production lot as those tested for benchmark values were then exposed to seawater and tested after 60 and 120 days. Figure 4 shows the retention of the five different properties after exposure at 23, 40 and 60°C. These retention values were calculated by comparing the average peak values after exposure to the benchmark values (obtained for the virgin materials). Therefore, the presented values indicate how much of the initial capacity is retained after a certain aging process.

In general, from the graph in Figure 4, it can be inferred that the exposure at 60°C was the most aggressive within the three evaluated temperatures, showing overall lower retention values: minimum retention of about 80% was found for temperatures of 23 and 40°C, while retention values as low as 60% for exposure at 60°C were recorded. When comparing the three types of rebars, it can be seen, that Type B rebars showed the lowest deterioration values (max of 15-20%) throughout all exposure conditions, whereas type A suffered the highest degradation (up to 40%). Type C rebars, however, show comparable results to Type B.

Figure 4. Strength retention of GFRP rebars after being exposed to seawater

After comparing the different physio-mechanical properties and their retention over time, it was seen that the most affected property was the tensile strength, with up to 40% of reduction after 120 days at 60°C. These values were higher than the ones found in literature, where Robert and Benmokrane (2013) saw a deterioration of 15% after exposing the rebars to a saline solution at 50°C. The difference can be attributed to the different rebar types that were tested, and most importantly, to the lower temperature used for the accelerated aging (50°C compared to 60°C).

The next most affected properties were bond and transverse shear strength, with decrease in strength of up to about 20%. Horizontal shear strength and the modulus of elasticity, however, were almost not altered by the aging process, in some cases those properties even showed increasing values (these low increases can be explained by the existing variance of the results obtained – see Table 2). The low deterioration effect on the modulus of elasticity was also reported by other researchers in the literature, who conveyed maximum degradation values lower than 5% after comparable aging processes (Al-Salloum et al., 2013; Robert and Benmokrane, 2013). This was attributed to analogous reduction of tensile strength and strain: since the modulus of elasticity describes the change of stress over strain, the effect of the degradation gets canceled when computing the mentioned slope.
