TEXTILE-REINFORCED MORTAR EXTERNAL STRENGTHENING OF CORRODED REINFORCED CONCRETE BEAMS

Charles K.S. Moy^{1*} and Silas Oluwadahunsi²

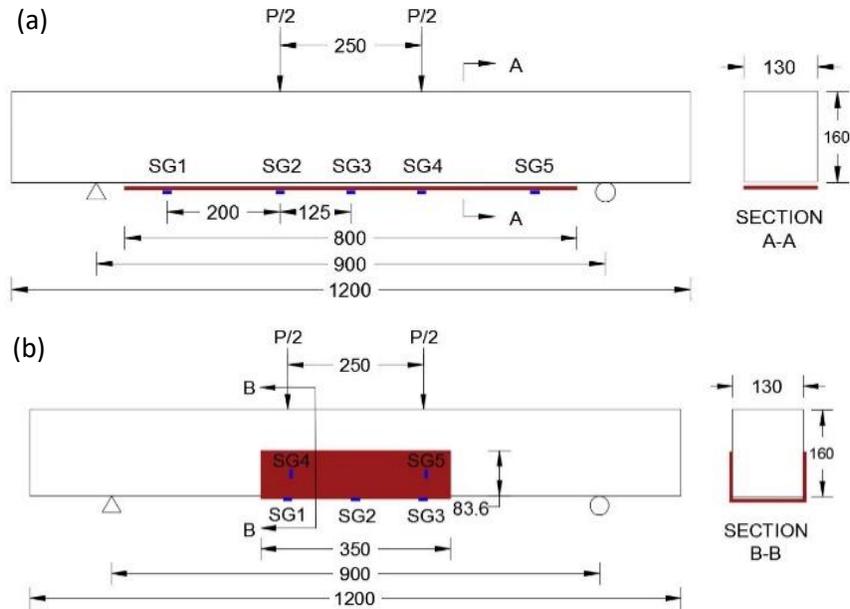
Fig. 2. Basalt-TRM strengthening scheme (a) laminate (b) U-Wrap.

Both strengthening schemes cover an equivalent area on the corroded specimens. Prior to the application of the TRM, the concrete cover over the corroded steel was removed, the bars cleaned and covered with fresh concrete. The surfaces to apply the schemes to (soffit and sides) were prepared by cutting grooves of approx.1.5 mm depth and width using a grinder (see Fig. 3). The surfaces were kept moist for over 24 hours before the application of the mortar in order to prevent early shrinkage in mortar.

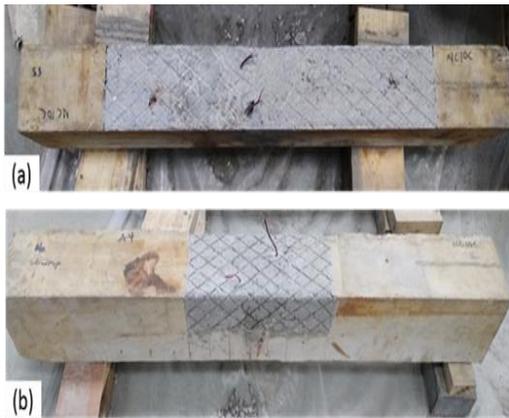
Fig. 3. Surface preparation (a) scheme 1 (b) scheme 2.

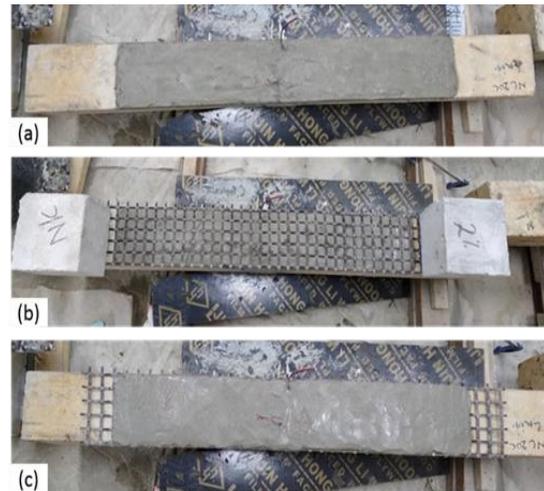
Fig. 4. TRM Application (a) First mortar layer (b) impression of textile into mortar (c) final mortar layer applied.

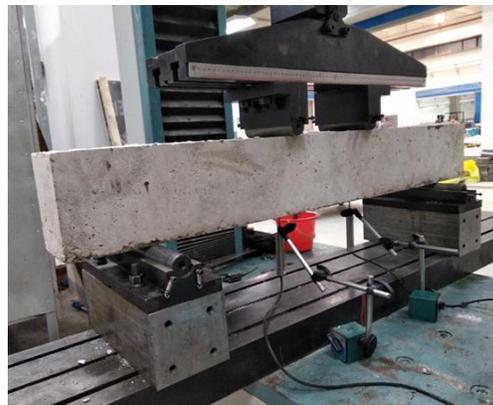
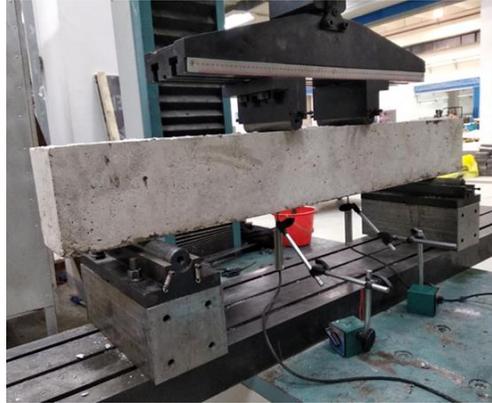
in a four-point bend setup (see

Fig. 5). Displacement rate was set at 1 mm/min. Clear span between supports was 900 mm while the loading pins were at 250 mm centres. Two linear variable displacement transducers (LVDT) were placed at the bottom of the beams, to measure displacement.

Fig. 5. Loading Setup.

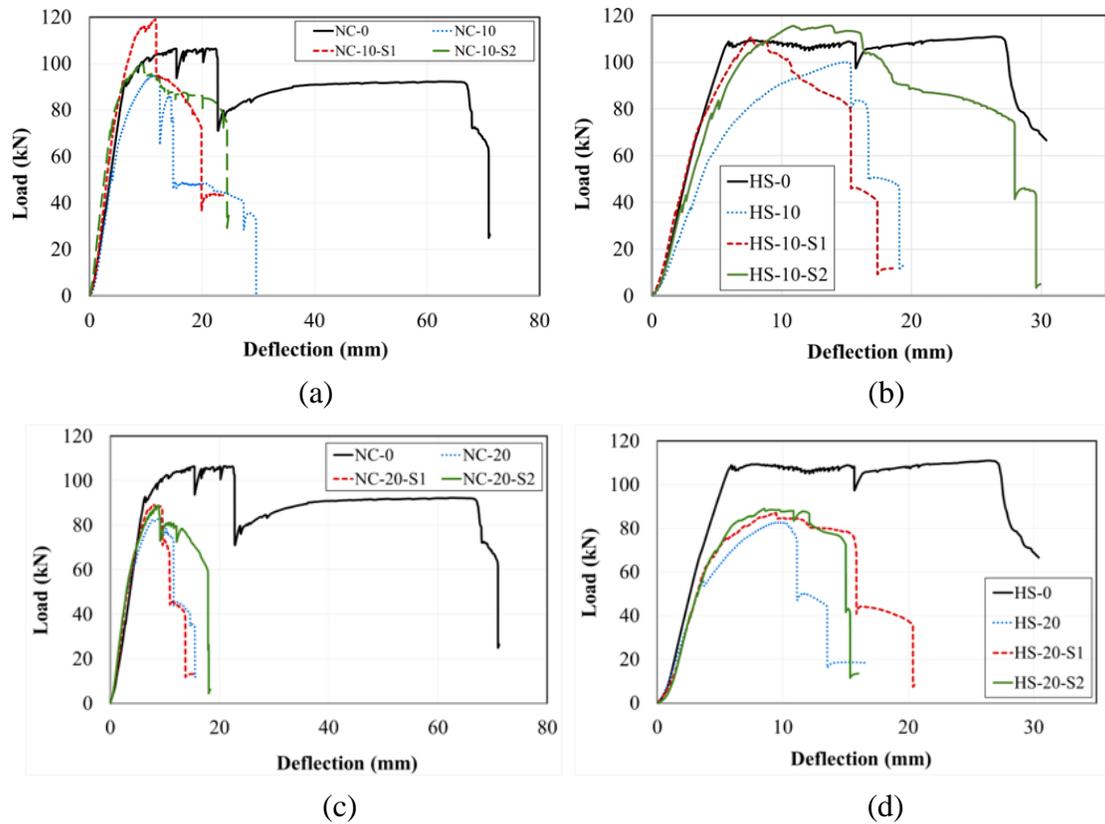
Fig. 6. Load-deflection plots (a) 10% corroded NC beams (b) 10% corroded HS beams (c) 20% corroded NC beams (d) 20% corroded HS beams.

Fig. 6(a) shows that NC-10-S1 gained higher strength increase compared to NC-10-S2, which only increased in load capacity, but was not restored to original strength. However, the latter exhibited better ductility. In 10% corroded high strength beams (See

Fig. 6 (b)), HS-10-S2 had a superior load increase and ductility performance, similar to that of the control specimen, in comparison to HS-10-S1. In

Fig. 6(c) and (d), high strength beams strengthened with both schemes showed higher ductile behaviour compared to normal concrete beams. However, none of these beams (20% corroded) was restored to original strength and ductile behaviour.

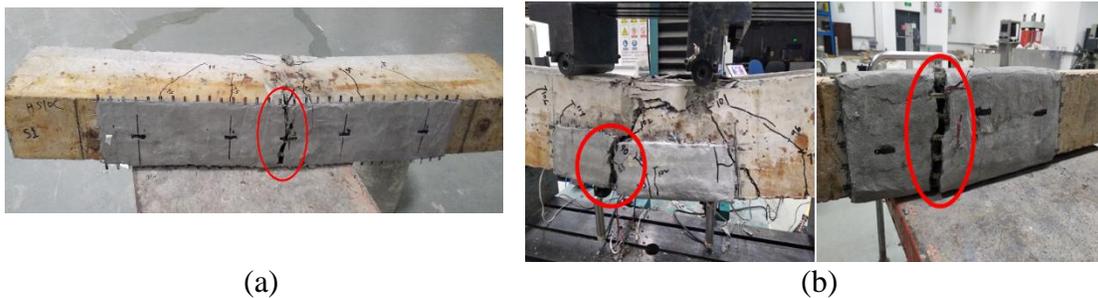
The failure of all beams tested starting with yielding of tension steel reinforcement and subsequent compression crushing of concrete at the loading points. Moreover, the ultimate failure mode observed in all strengthened specimens is fibre rupture. This is depicted in Fig. 7 showing failure of representative specimens (HS-10-S1 and HS-10-S2).

Fig. 7. Failure modes (a) Scheme 1 (b) Scheme 2.
