## Rehabilitation of an old Concrete Lohse Arch Bridge: Replacement of all hanger

The Kimitsu Shinbashi Bridge is a Lohse arch bridge with reinforced concrete arch ribs and prestressed concrete deck slab. On October 23, 2008, it was discovered that one of the 40 hanger connecting the arch ribs and deck slab had broken. The bridge was closed to traffic and breaking mechanism followed by a detailed investigation. Repairs were effected step by step, ensuring the safety of the bridge throughout the process. This report describes the circumstances and procedures leading up to the replacement of hanger, and reports on the hanger replacement work utilizing newly developed tension releasing equipment.

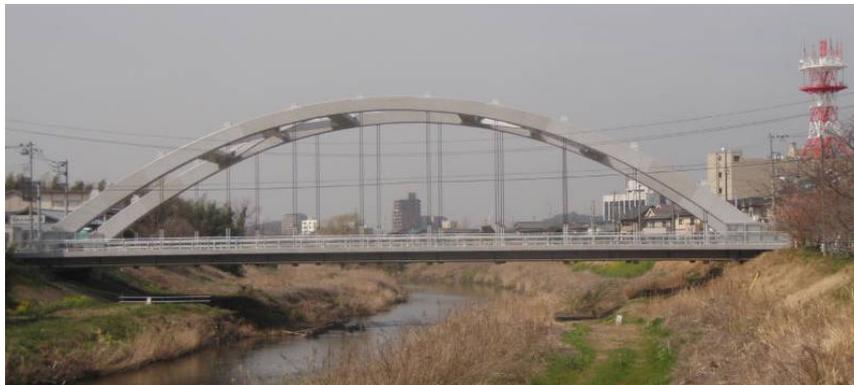
**Photo 1. Retrofitted Kimitsu Shinbashi Bridge**

The Kimitsu Shinbashi Bridge is concrete Lohse arch bridge constructed in 1973. It has a length of 68.3 m, width of 18.2 m. The deck slab is supported by 40 hanger, arranged with pairs of steel bars (32 mm dia.) at 10 locations each on the upstream and downstream sides of the bridge. The original steel bars were coated with anti-corrosion paint, and then sheathed in stainless steel pipes. Photo 1 is an overall view of the retrofitted bridge.

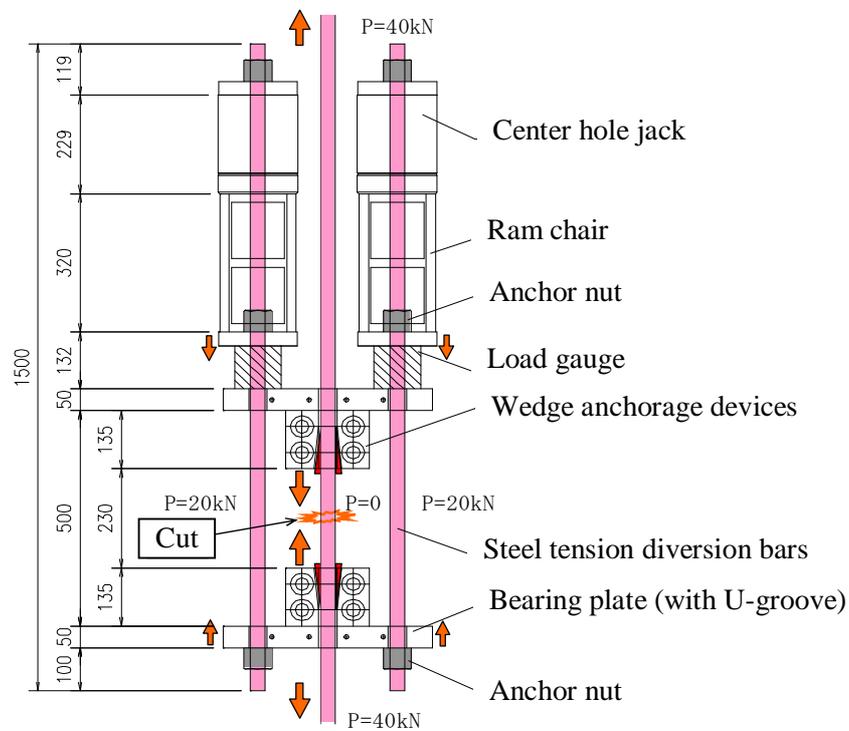
Figure 6. Tension releasing equipment

Tension releasing equipment using wedge anchorage devices was developed as a system to meet all these requirements. The equipment is illustrated in Figure 6. The anchorage wedges and anchorage cones both have a two-part structure so that they can be easily attached wherever required. The steel tension diversion bars are fitted with hydraulic jacks and load gauges. The procedure for releasing tension is as follows.

- Fit the wedge anchorage devices to the old steel bar, and put the tension releasing equipment in position.
- Use the two hydraulic jacks to tension the steel tension diversion bars. The tension is transferred to the old steel bar through the bearing plates and anchorage wedges, releasing the tension in the steel bar between the wedges.
- Cut the old steel bar between the anchorage wedges with a gas cutter. The tension between the wedge anchorage devices is transferred to the tension diversion bars.
- Slowly release the hydraulic jacks. The tension is released over the whole length of the steel bar.

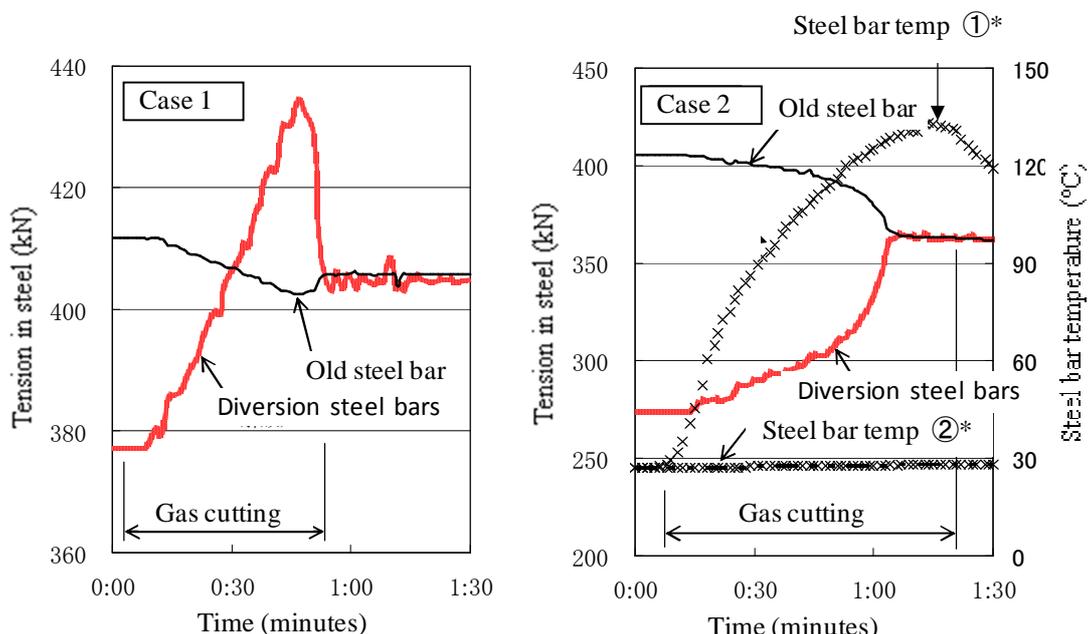
**Figure 7. Changes of tension in steel bars**

The testing was performed for two different cases in order to take account of potential error on site. Assuming residual tension of 40 kN at the time of release for Case 1, and residual tension of 140 kN at the time of release for Case 2, the test involved producing a 1 mm offset in one of the sets of wedges. The resulting changes in tension at the time of cutting in the old steel bar and in the steel bars for taking over the tension are shown in Figure 7.

(\*Steel bar temp ① : under wedge, Steel bar temp ② : over wedge)

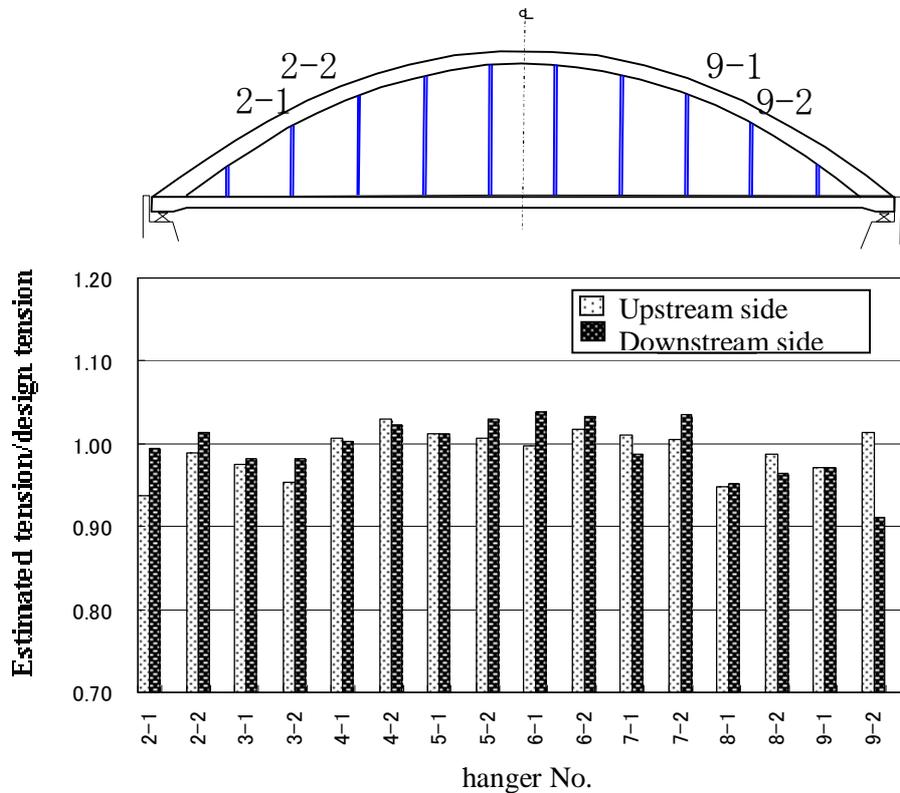
Figure 8. Comparison of tension in hanger with design values

The ratios between estimated and measured tension of hanger at completion of repairs are shown in Figure 8. The tension in the hanger is within a range of 0.91-1.03 relative to the design values, with the exception of hanger at the ends of the bridge, confirming that the tension is acting as designed. These measurements will be a very useful benchmark for detailed inspections in the future.

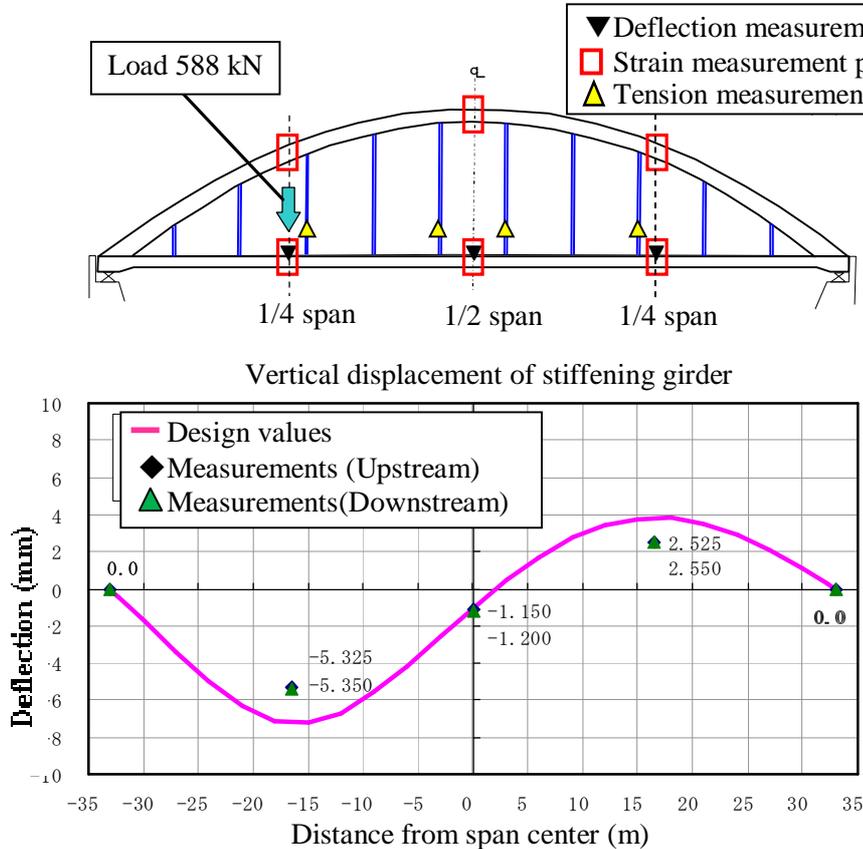
**Figure 9. Results of loading test on bridge after repairs**

The results of measurement for the case of loading at 1/4 span are shown in Figure 9. The graph on the left shows the deflection of the deck slab under load. The measurements of deck slab deflection and of strain in the arch ribs and deck slab match well with the calculated

estimates, confirming that the required flexural stiffness and load carrying capacity have been achieved. The distribution of strain in the arch ribs and deck slab was consistent with Bernoulli-Euler model assumptions, confirming that each of the members was behaving as an elastic body.
